ST. THOMAS A BECKET'S WELL,
OTFORD, KENT.

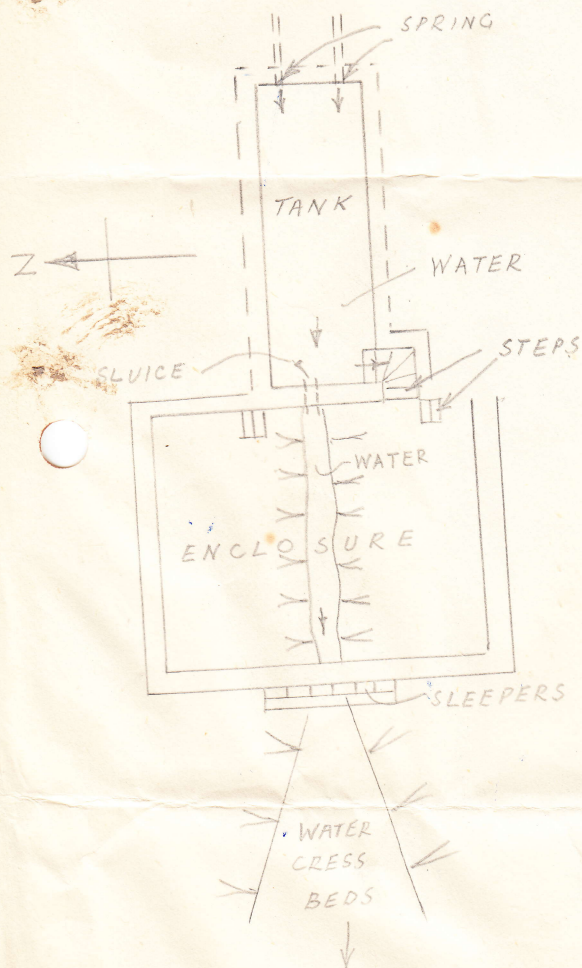
SKETCH PLAN OF
WELL

Due to the want of maintenance over a period of many years the masonry is now in a bad condition and a considerable amount of work is necessary, if the monument is to be preserved.

Tank. The masonry to the tank is not in a bad condition but the following defects should be attended to without delay.

Take down the stones forming the bulge at the west end of the north wall and re-build replacing each stone in its original position.

Clear away the ivy, brambles and earth from the tops of the walls, reset any loose stones and waterproof top.

Remove the small saplings growing in the masonry, reset stones disturbed. Consolidate the masonry to the corner by the steps where the stones have fallen

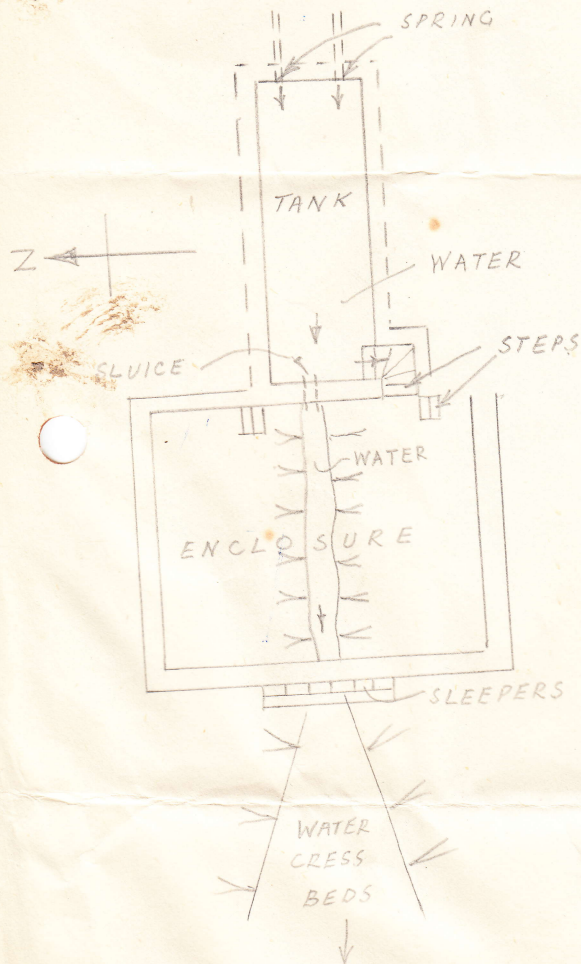
SKETCH PLAN OF
WELL

Due to the want of maintenance over a period of many years the masonry is now in a bad condition and a considerable amount of work is necessary, if the monument is to be preserved.

Tank. The masonry to the tank is not in a bad condition but the following defects should be attended to without delay.

Take down the stones forming the bulge at the west end of the north wall and re-build replacing each stone in its original position.

Clear away the ivy, brambles and earth from the tops of the walls, reset any loose stones and waterproof top.

Remove the small saplings growing in the masonry, reset stones disturbed. Consolidate the masonry to the corner by the steps where the stones have fallen

Reset the loose stones in the west wall.

Rake out the loose cement pointing in the west wall and repoint, in lime mortar including all open joints in the other walls.

Remove the earth so as to expose the steps to the north and south of the west wall.

Remove the debris from the bottom of the chamber.

Remove the trees growing near the wall at the north east and north west corners and branches of the tree resting on the west wall.

Remove the small bushes, saplings to the south wall and the ivy from all the walls.

Rebed all the loose stones to the walls and repoint all open joints.

Remove the sleepers leaning against the west wall and make good masonry behind if necessary.

Remove all the brambles etc growing inside the enclosure, clean out the water way and rebed the stones at the sides.
