#### Introduction

#### The Condition Report

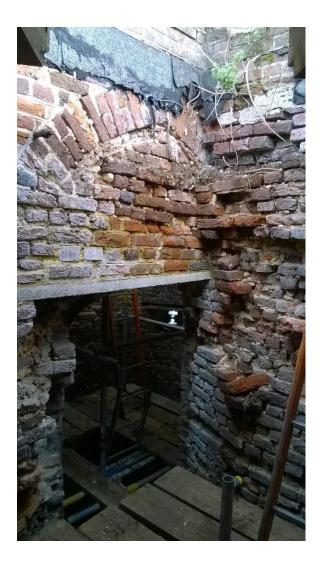
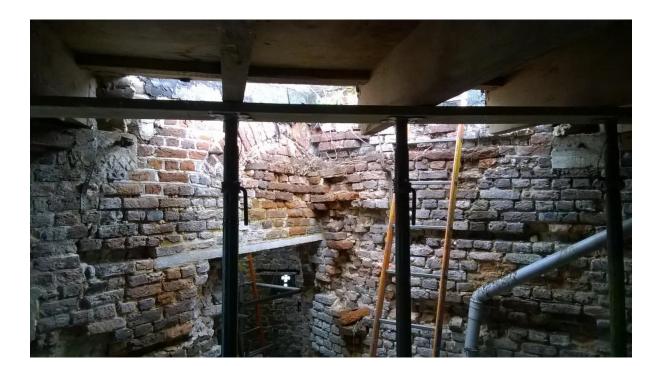
Despite the rain we have had this week, Pierra have been on site and stripped the roof of the remaining felt, as well as removing the corner that was close to collapse. Originally we were only going to repair the damaged corner, but after stripping the felt is has become apparent that the entire roof will need replacing as the structure underneath is not useable.

The brickwork under the corner of the roof that was damaged will need work before the roof can be reinstated. It is evident that it is not stable enough to hold the foundations for the roof due to water damage causing the bricks to disintegrate and become loose. The next step will be to stabilise this corner before the new roof can be installed. At present, the old roof remains in situ to protect the rest of the tower.

An architect has visited the Tower and showed particular interest in the little gargoyle that still remains, the mid level fireplace and the diagonal slots in the wall that we think were used to put the beams for the ceiling and flooring. He is keen to be present when any brickwork is removed to expose any voids as he thinks there may be more beam slots behind them.

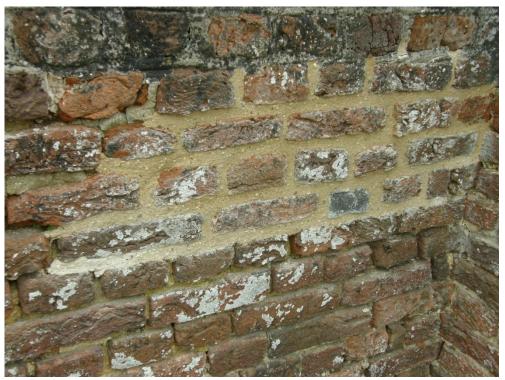
A test section of the new mortar. This matches the original mortar in terms of colour and consistency.

Two types of mortar have been tested on sections of the upper brickwork and it has been decided to use Westerham sand within the lime mix. This has a slightly orangy yellow tone, similar to the original mortar. The architect pointed out to me, though, that much of the brickwork has wider mortar spacing than usually found in buildings of this type and age and we may feel that the new mortar is a bit dominant when we first see it. This however is the way it once was and, as he surmised, it would appear the tower was built in a bit of a hurry. (The whole palace was built in four years so we need hardly feel surprised!)

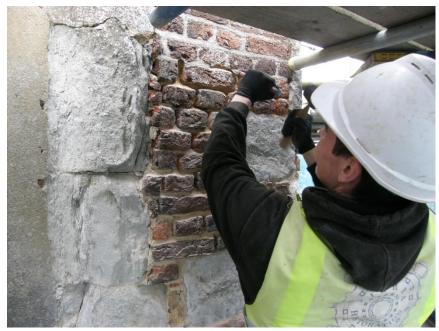
Notice the depth of the cut and the poor state of the stonework

The result of this re-pointing will be that it reduces significantly the speed of deterioration. The cement had been applied in quite shallow amounts and comes away quite easily. The old mortar will be cleaned out to 20mm so that the new mortar has a good hold on the brickwork. Certainly the walk around the tower at close quarters yesterday, demonstrated in what a poor state some of the brickwork had become.

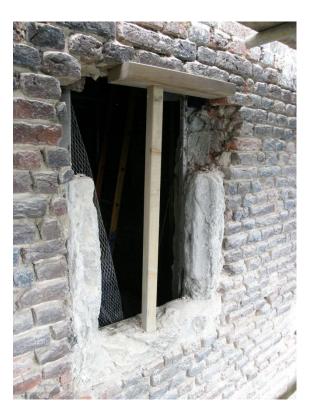
Awaiting new stonework

As you will see from the photos, much of the Kent rag stonework – particularly the window mullions, had reached a pretty poor state of deterioration. In consequence as the builders have progressed around the tower, they have removed the worst of the stonework and mullions which are beyond saving. These will be replaced with new stonework in due course.

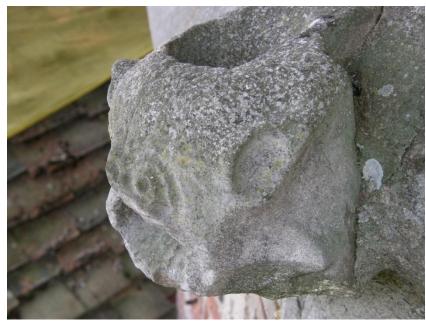
Can you make out 'Gollum' but lacking his nose?

Finally, just a point of interest, at the centre of the top of each window, there would appear to have been some design or sculpture. In every instance, bar one, they seem to have been chipped away – so maybe it was another example of reformation zeal if they were images of saints (it was an archbishop's palace, remember). However the remains of one gargoyle-like

figure remain. As far as I could ascertain, it resembles a Gollum-like creature – so may be it scared all the saints away!

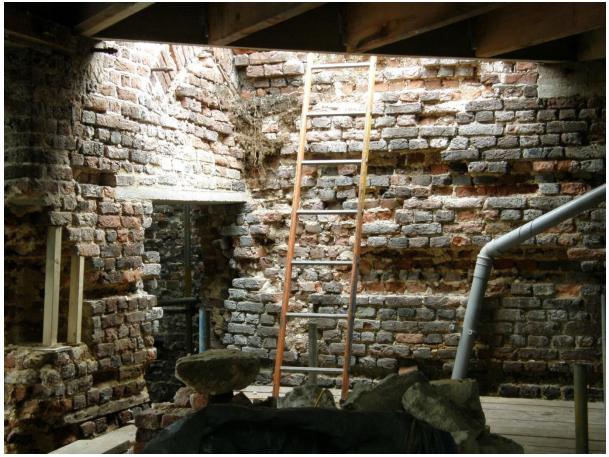
You can get a good idea on how much new replacement brickwork will be required - and this is just one top floor section.

No work has progressed on the interior as the builders have been awaiting delivery of the hand-made 'Tudor-style' bricks, which is now imminent. This will allow them to re-build all those unsafe areas of brickwork on the upper storey.

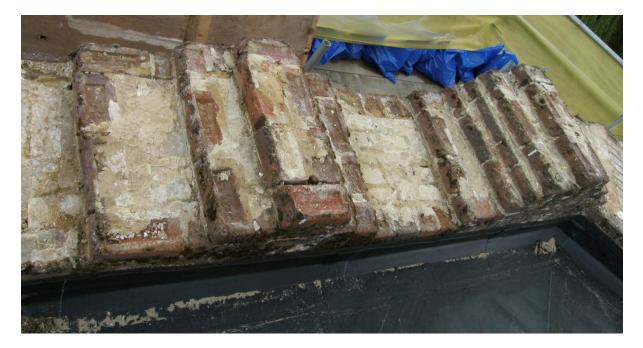
!: The Balustrade with the concrete removed

Meanwhile, the balustrade surrounding the tower roof is now receiving a thick layer of lime mortar along its top surface (#2). Previously, this was coated in cement (#1). Once dried, weather permitting, the roofing felt will be folded up and over the balustrade and tidily pinned with timber batons all around the exterior, completing the water-tight process.

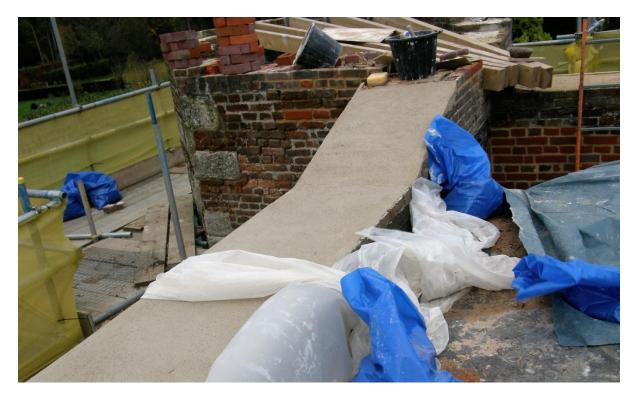
2: - and as it is today

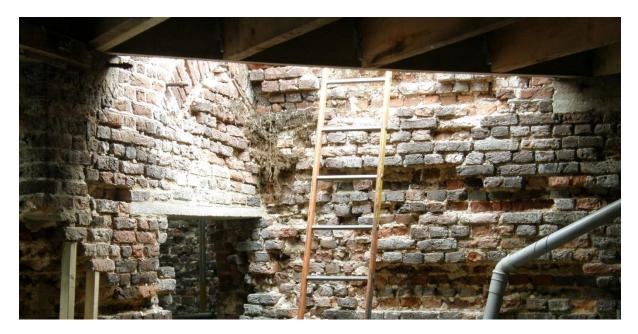
3: The upper brickwork below the roof in a state of collapse

Over the past month, Pierra have replaced all the upper interior brickwork which had become detached and destroyed beneath the blocked drain on the roof (#3). The result is a very fine and attractive piece of work. (#4) They are combining different tones of brick so that they closely resemble the original brickwork. If this is an indication of their standard of work overall, then we can be very pleased they are on site.

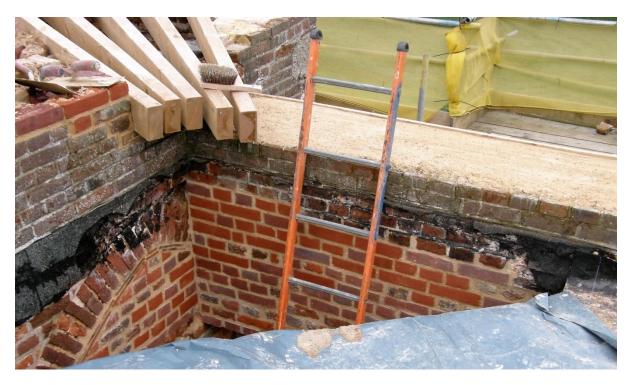
4: - and today, with it re-built with new bricks and lime mortar

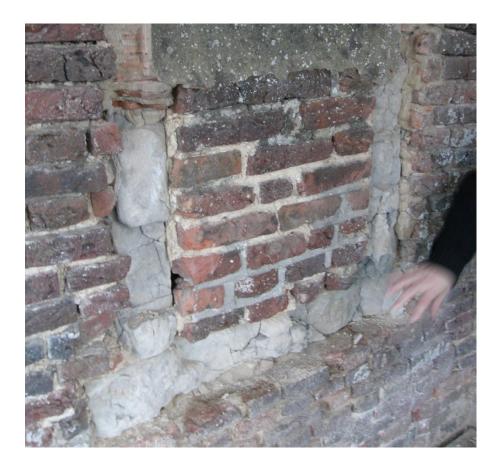
5: Mullions and cil, once single pieces of Kent Rag, reduced to rubble with the effects of a cement coating. Ominous what state parts of the tower had reached even though not previously visible.

This week the stone masons arrive. You may see them chipping their blocks of Kent Rag on site if you are nearby. As you know, they are replacing many (sadly not yet all) of the window mullions and cills which have become unsafe through weather erosion over the centuries. Sad to see the effects of prolonged exposure to cement that these cills have suffered. (#5. The cement covering on this one has caused the original stone to completely shatter)
