**Report on an excavation at  
Castle House,  
Otford, Kent  
2016**

Kevin Fromings BA (Hons) MA

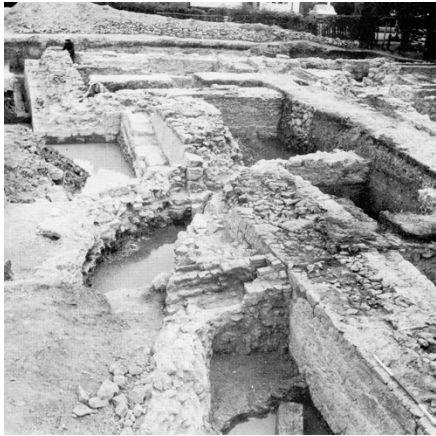
*Fig. 2: Otford Palace excavation on completion, 1974*

Very little of the palace site has been investigated archaeologically. In 1974 about 600 square metres of the southern range were excavated by Otford and District Archaeological Group – and subsequently Kent Archaeological Rescue Unit – in advance of a housing scheme on Bubblestone Road (Fig. 1). This showed that extensive foundations remained (Fig. 2), and were, in places, only 120mm below the ground surface.

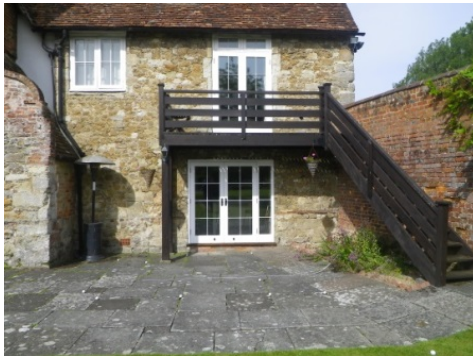
*Fig. 4: The site before excavation*

In 2015 a series of trial trenches was excavated over the intended area of the kitchen extension. The area investigated was part of a paved patio (Fig. 4), extending out from the current kitchen door by 2.5m, with a 5m width.

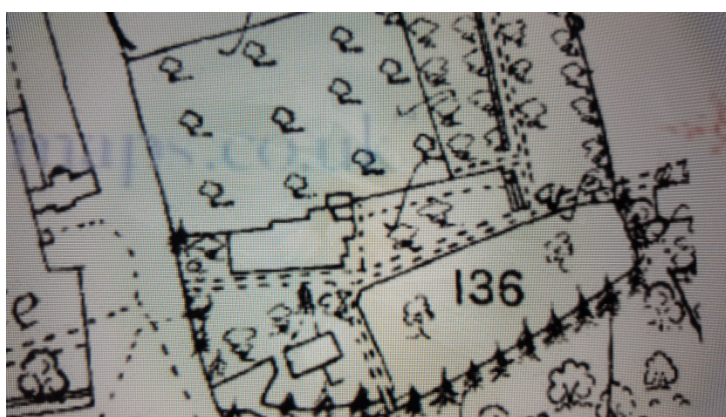
*Fig. 6: 1869 O/S map showing extension on Castle House. The apsidal effect would appear to be an optical illusion, caused by the way the dotted line has been marked*

Research revealed that the 1869 1:2500 Ordnance Survey map (Fig. 6) shows an 'extension' on the side of Castle House exactly over the excavation site. According to the map the structure did not extend further than the current paving. This feature does not appear on smaller-scale maps.

The Ordnance Survey map of 1869 clearly shows the building as part of the structure of Castle House. Some of the 19th century detritus could easily be as late as this; however, it is worth considering that the 1869 map may have been copied from an earlier map, so the features were not extant at the time. Research to date has not identified these features appearing on any available earlier maps. It should not be ruled out, then, that the building was a short-lived structure that was constructed sometime after 1844, and demolished in the latter half of the 19th century, but this is unlikely. To add to the uncertainty, a version of the building is discernible on the 1898 Ordnance survey map, but none of the demolition material seems to be this late.

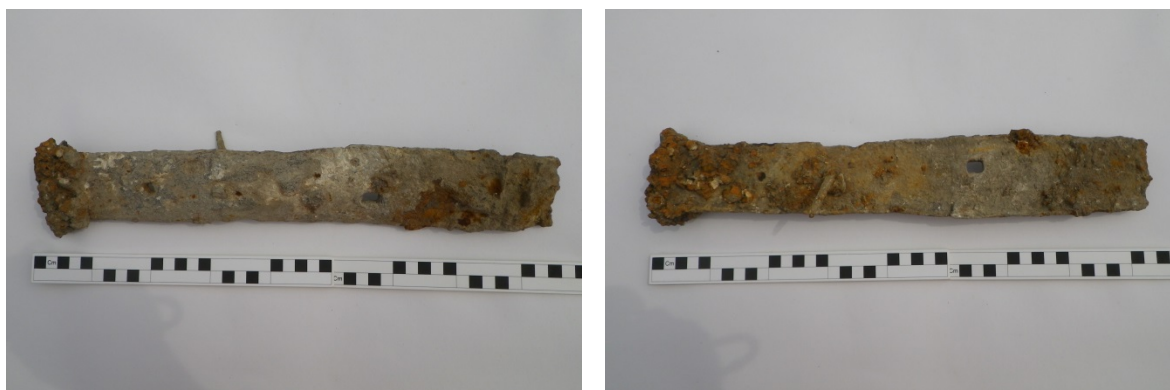
*Fig. 7: Large iron door hinge*

Excavation revealed a continuation of the features found in the trial trenches. The sequences were exactly the same, with the same incidence of brick and peg tile, and concentrations of primarily 19th century pottery. An iron door hinge was lifted (initially thought to be 'window furniture') which was hand-made, probably locally (Fig. 7). This cannot be given any particular date, based on design, but is presumed to be contemporary with the building.

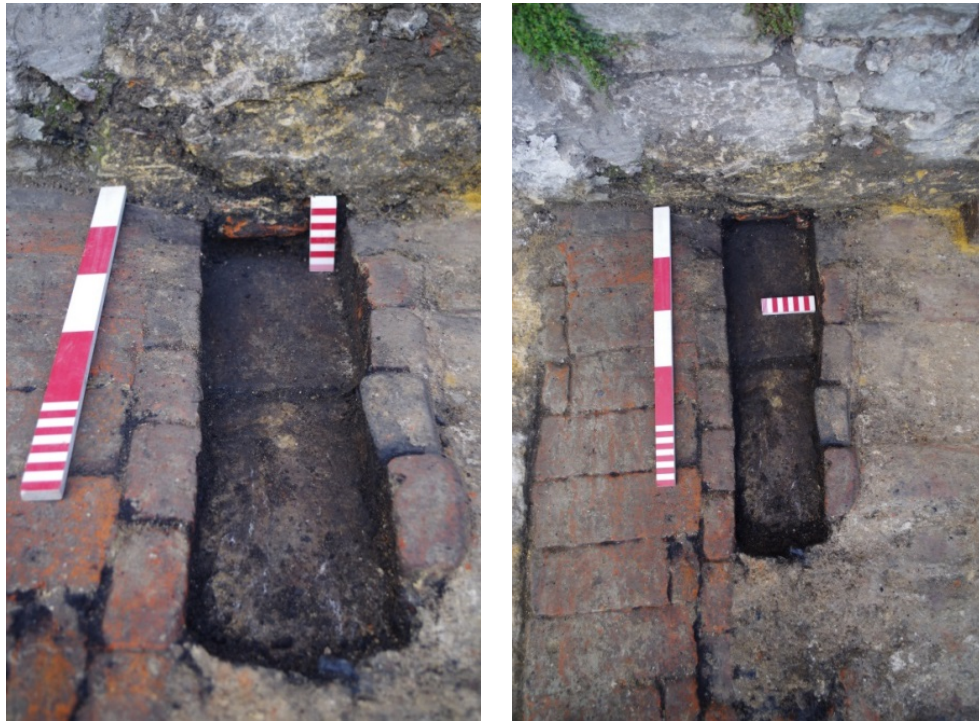
*Fig. 8: Slot continuing under extant house wall*

The late 20th century wooden balcony and steps were dismantled, and the supporting concrete slab was lifted, thus finally revealing the entire brick fireplace. Once removed, and the rubble layer cleared, a slot was revealed in the brick hearth (Fig. 8); this was lined with stone slabs along its entire length, save for a crude repair carried out with bricks at the edge of the hearth. The slot was 170mm wide by 90mm deep. It appeared to run the whole length of the building, from the extant house wall, across the fireplace and across the compacted mortar surface to disappear under the east section (Fig. 9). At one time it appears to have run under the extant house wall to the other side.

The slot appears to be contemporary with the hearth, and thus is an original feature of the building. Further excavation revealed it to be full of compacted coal chippings along its whole length, other than two iron nails.

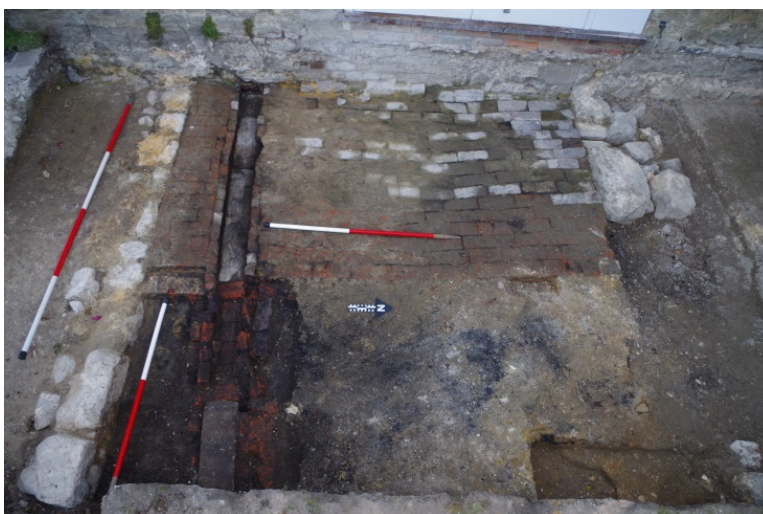
*Fig. 9: Complete slot cutting through floor*

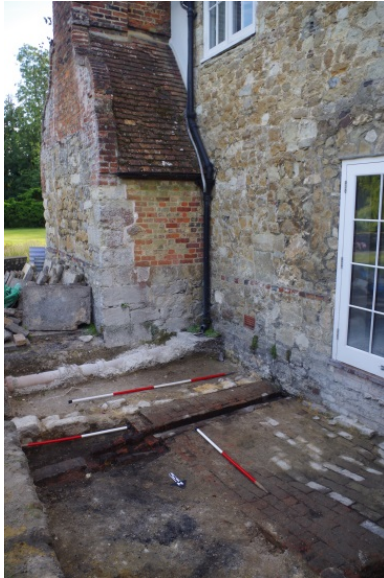
*Fig. 10: View south past modern drain to 17th century chimney breast*

To the south of the new building lies the modern ceramic drain from the house (Fig. 10), but this is outside the building and has not interfered with the archaeological remains.

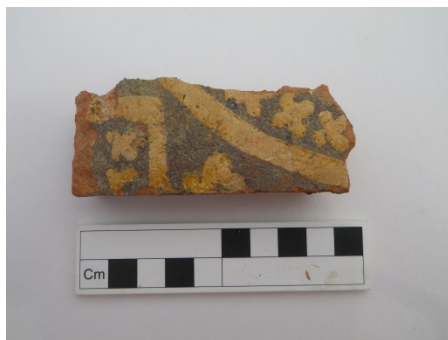
*Fig. 11: Floor tile fragment*

It is unfortunate that there is currently nothing to date the fireplace itself other than the bricks, as the rubble layer probably represents demolition of the building. Aside from peg tile and brick fragments, there was nothing in this layer but late 18th/early-mid 19th century material. The one exception to this was a fragment of decorated glazed floor tile (Fig. 11), but this was probably from the nearby Archbishop's Palace.
