Significance assessments and change of use:

The case of Otford Palace

Holly Cooper

Holly Cooper
MArch Architecture
Stage 5
University of Kent

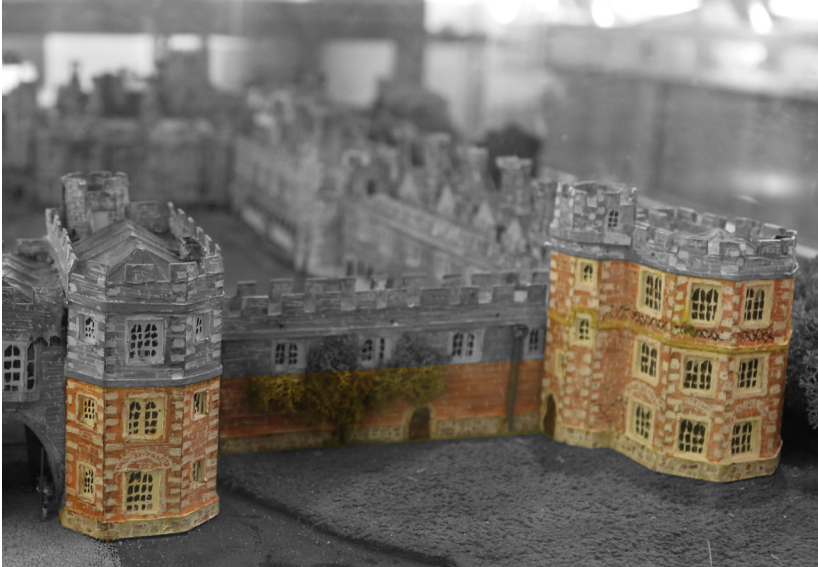
Figure 7: *Otford Palace; The Surviving Tower, Short Gallery & Gatehouse* (2017)

Only fragments of this grandeur remain, with the surviving buildings highlighted in Figure 7, where the scale of The Palace can be seen. The north west Tower and Gatehouse are listed as scheduled ancient monuments, whilst the former short gallery has been converted into a row of Grade II* listed cottages and further ruins Grade II listed.

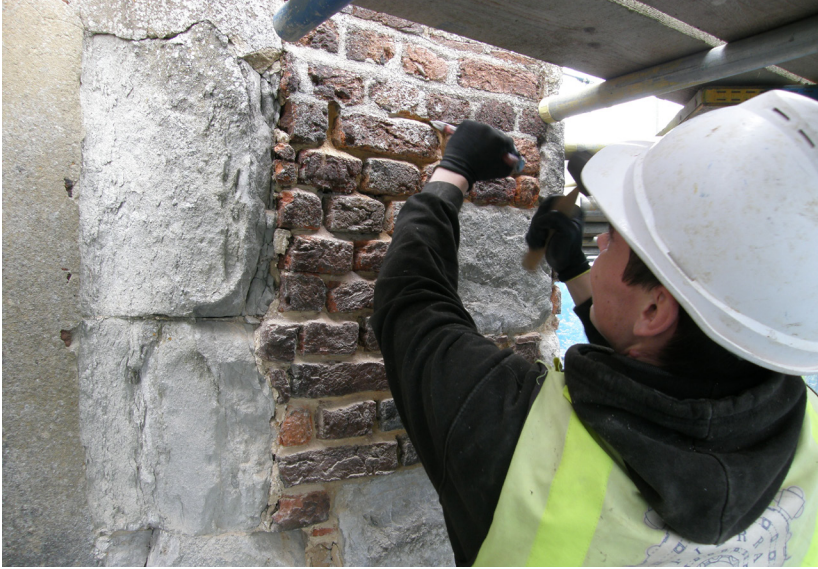
Figure 14: *Recent Repair Work To Mortar Joints (2015)*

Whilst recent repairs have structurally secured The Tower, respect dwindles as it remains open to the elements. In contrast, The Gatehouse is watertight and currently used for storage. Respecting the building's heritage and longevity should be a key factor when evaluating any future intervention for The Palace.

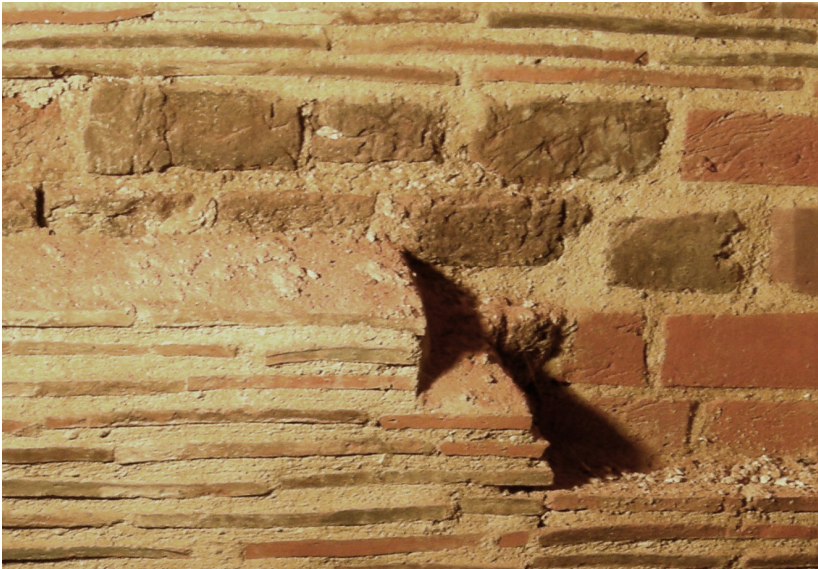
Figure 19: *Previous Repair Works To The Tower* (2015)

From a technological perspective, the construction of The Tower, Gatehouse and ground floor of the short gallery (now cottages) is predominantly 16thC. There is evidence of structural arches within the fabric of the remaining Tower, which play a vital role in countering any subsidence. The main documentary elements of The Palace include inscribing to the internal façade of The Tower seen in Figure 18. This provides evidence of historical vandalism.

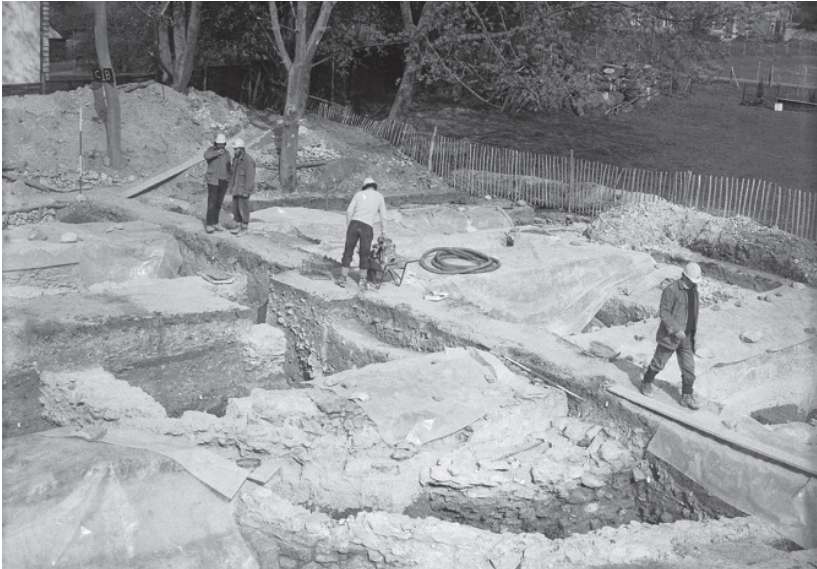
Figure 20: 1974 Excavations of Otford Palace (1974)

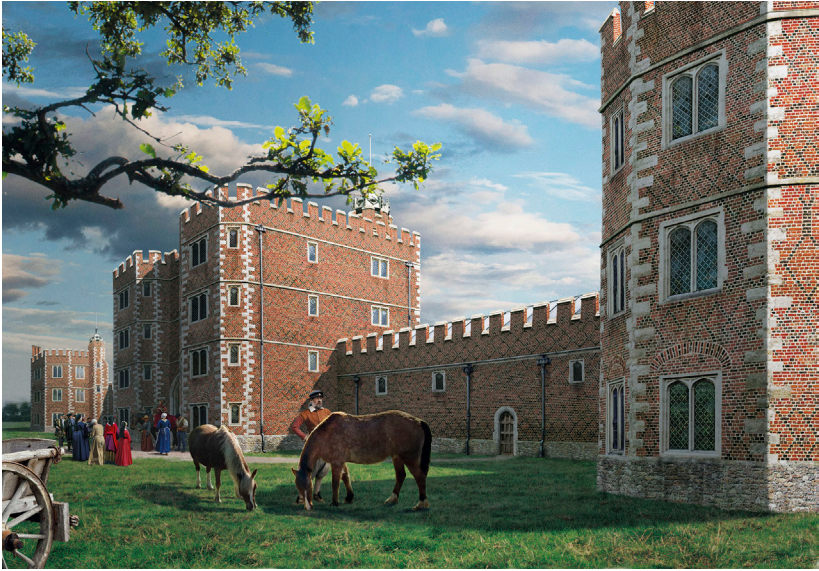
Figure 24: *3D Graphical Representation Of The Complete Otford Palace (2017)*

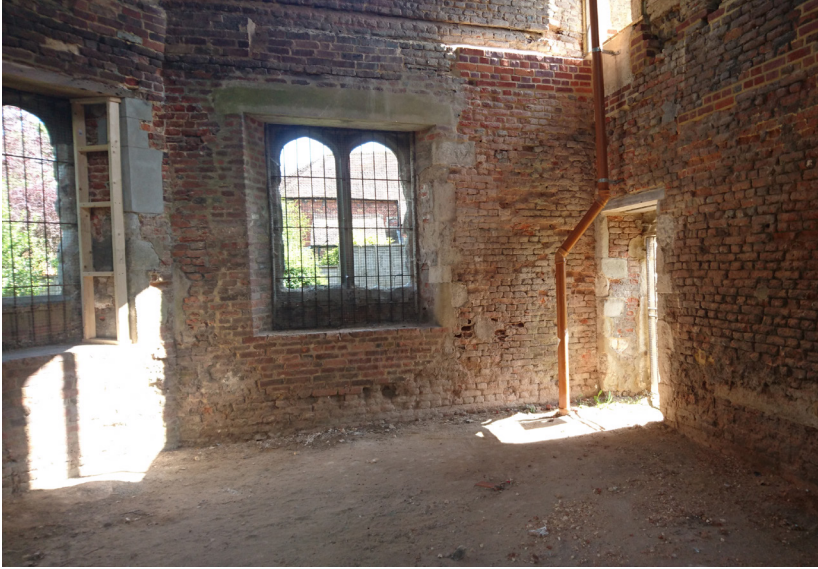
The remaining Tower takes the form of an unequal octagon, with each floor designed to be an individual room. These spaces receive an abundance of light from windows on all aspects, as seen in the following imagery. An adjacent structure to the main Tower housed the staircase, some of which is still present today. Artistically, Warham's rebuilt estate was subdivided, with a courtyard to the north and manor house to the south, enclosed by galleries, gatehouses and Towers. The scheme was typically medieval, and showed little renaissance influence despite the artistic movement's popularity at the time. (Clarke 1975:100) The stone window jambs to both The Tower and Gatehouse join with pointed arches at the head, and are mostly formed of two openings with a central mullion. Smaller windows also appear within The Tower, providing light into the stairwell.

Figure 26: *Ground Floor Of Tower, Facing East* (2017)

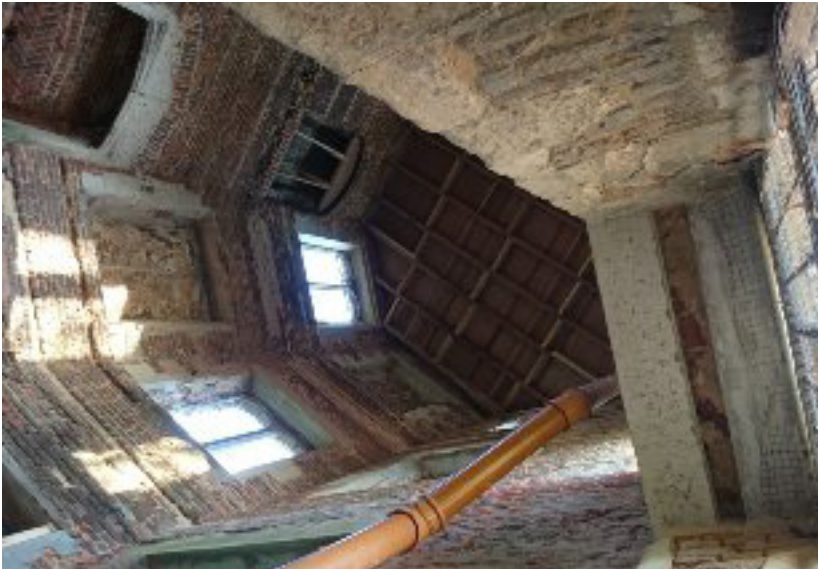
Figure 27: *Upper Floors Of The Tower, Currently Forming A Void* (2017)

No formal educational use existed on the site, however, the remaining aspects of The Palace provide an informal education. The doors to the main Tower and staircase enclosure are currently barred, but the internal features of both spaces are clearly visible, as seen in Figure 26 & 27. These include: fireplaces; internal lintels and part of the original staircase. The possibility to educate visitors should form part of any future intervention as it contributes to The Palace's long-term conservation and community engagement.

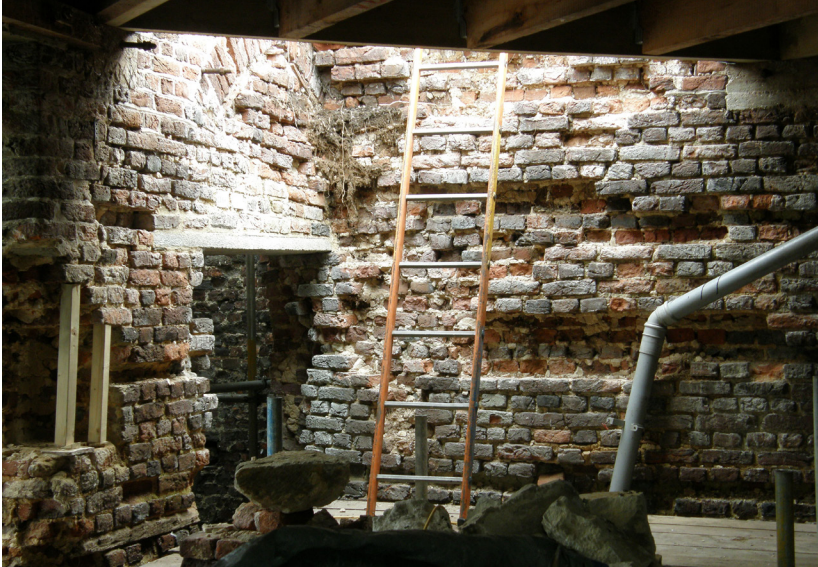
Figure 29: *Recent Repair Work To The Tower* (2015)

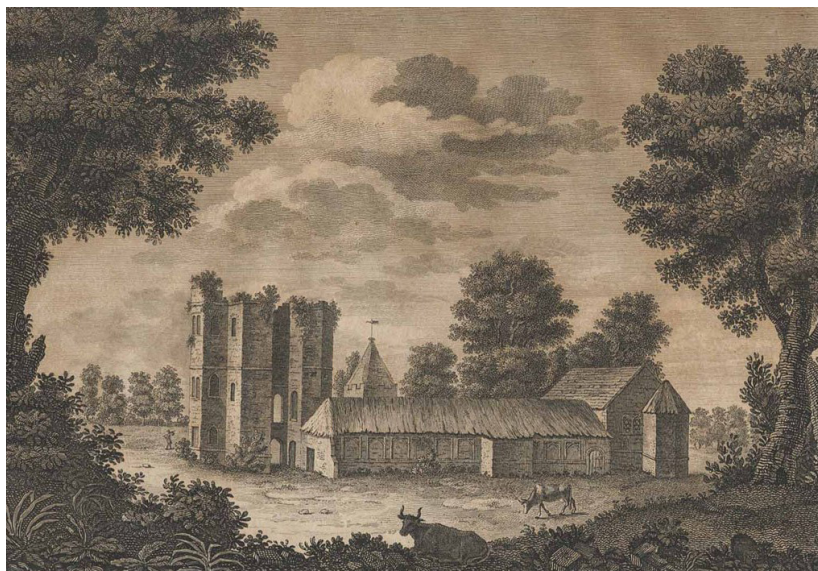
Figure 33: View From S.W. Of Remains Of The Tudor Northern Range (18Thc)

Figure 33, created by I.Bayly shows The Palace earlier. The 18th Century engraving shows the remaining northern range from the south-west. Again it depicts the short gallery as single storey, and The Gatehouse at a reduced height.

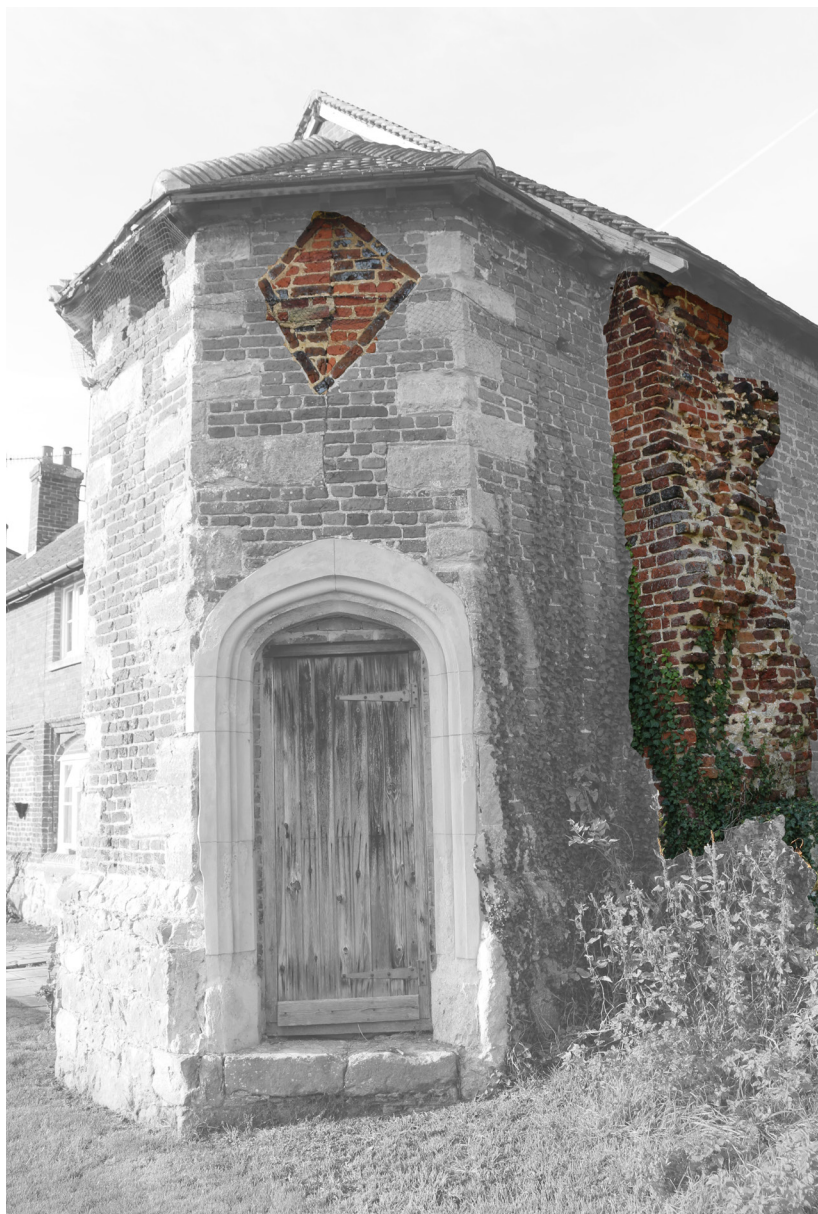
Figure 35: *External Patterned Brickwork&Remains Of Brickwork Connections*(2017)

Access was prohibited to the interior of The Gatehouse with no viewpoints in. Externally, The Gatehouse would be taller than it is today, however, this is not seen as imperative in its conservation. Crucial elements of The Gatehouse to preserve include the external brick patterns similar to those of the tower, as well as a vertical strip of broken brickwork that is seen to the south, clearly documenting that it was once part of a much larger structure.

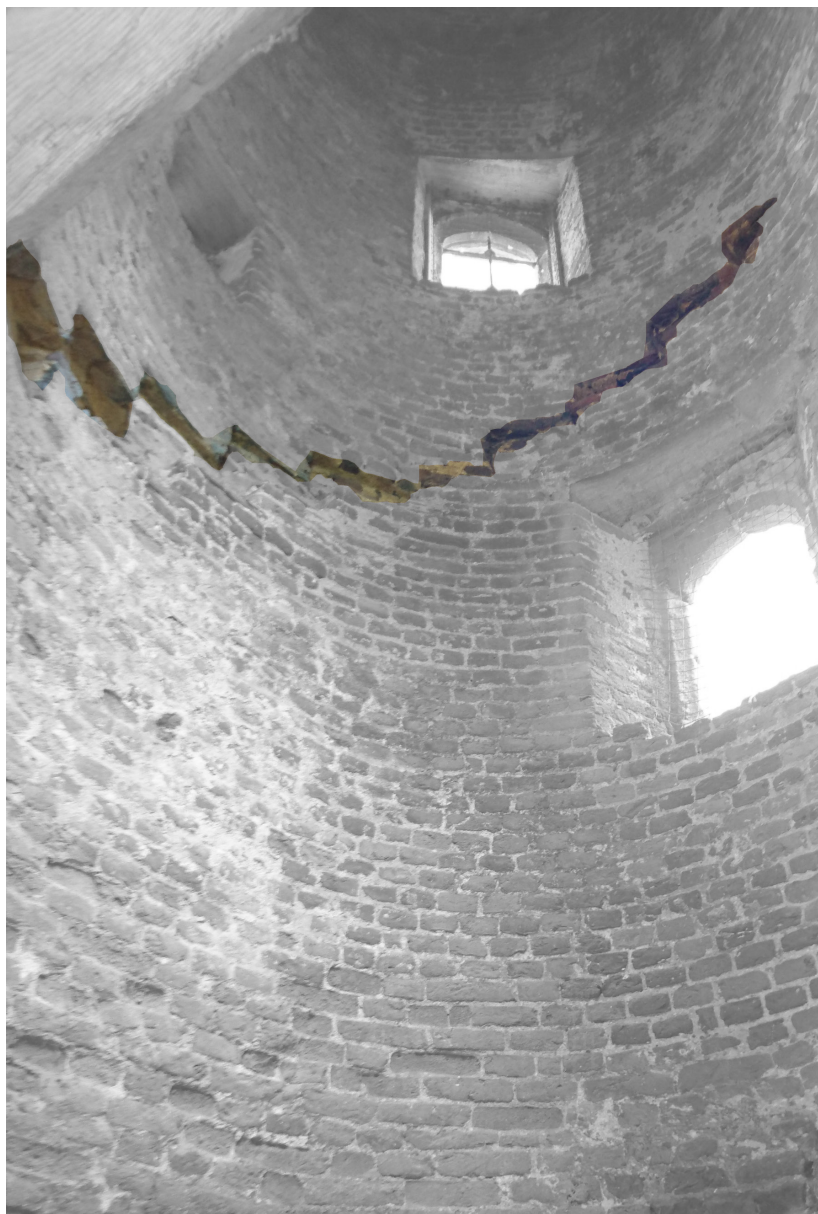
Figure 36: *Surviving Circulation Tower And Staircase Remnants* (2017)

Items of lesser significance include the remaining stones inside the stairwell. Though archaeologically important, the re-use of the stairwell for modern circulation purposes would take precedent. Another disposable element is the modern flat roof of The Tower. Historical Images show a parapet roof, continuing the elegant brickwork and emphasising the grandeur of the estate.

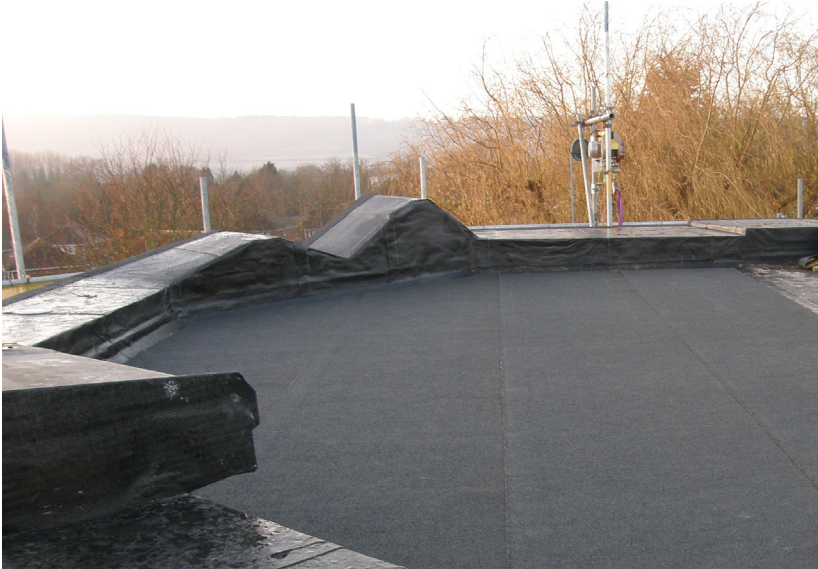
Figure 37: *Unsympathetic Flat Roof To Tower* (2017)

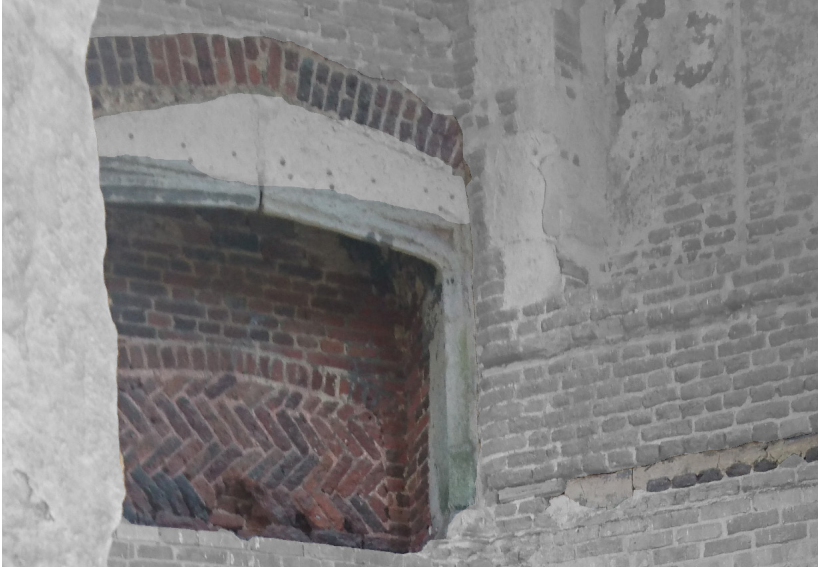
Figure 38: *Original Fireplace and Structural Arch* (2017)

Though easily mistaken as a fireplace, this is a former doorway to The Gatehouse. This can be identified due to the differing proportions of fireplaces shown in Figure 38 which display the traditional medieval landscape orientation. In addition, the stonework surrounds also differ in style and proportion to those visible around fireplaces in The Tower. Given that Warham designed and built The Palace in one phase, it is unlikely that they would substantially differ.

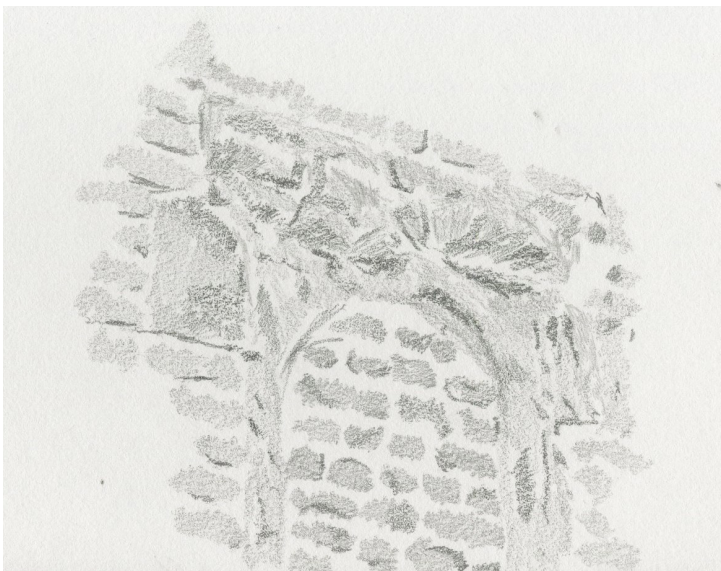
Figure 39: *Sketch Of In-Filled Window To The Gatehouse* (2017)

Infilled Windows

Figure 39 illustrates a window on the north elevation of The Gatehouse. The brickwork used in the infill is of a similar colour and texture to that surrounding it, suggesting that it was once part of the larger estate. The stonework surrounds are larger than those of The Tower, indicating it was considered a separate structure with design variation.

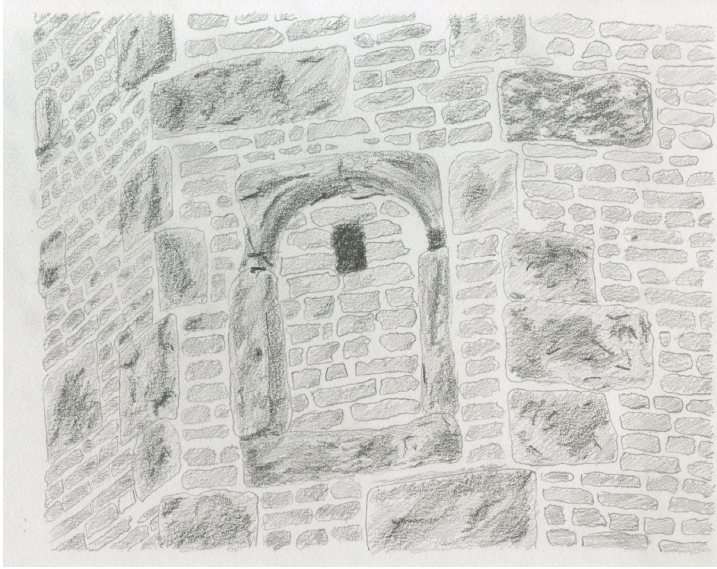
Figure 40 depicts another in-filled window, again the internal brickwork is identical to the external, indicating that it was from the same stock. An inward opening has also been maintained, as the bricks either side align to form an opening. The large structural cornerstones of The Tower are also visible within the image and are prevalent throughout the scheme.

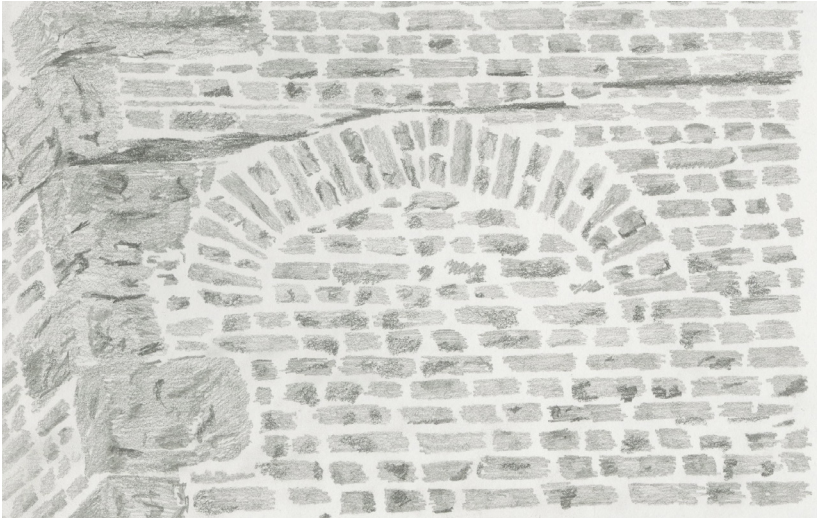
Figure 41: *Sketch Of Brick Structural Arch* (2017)

Structural Arches

This arch appears on the south facing wall, confirming the existing of subsidence in that area. The crack directly above it also highlights a fault. This is significant as it shows construction technology within the period was fairly advanced.

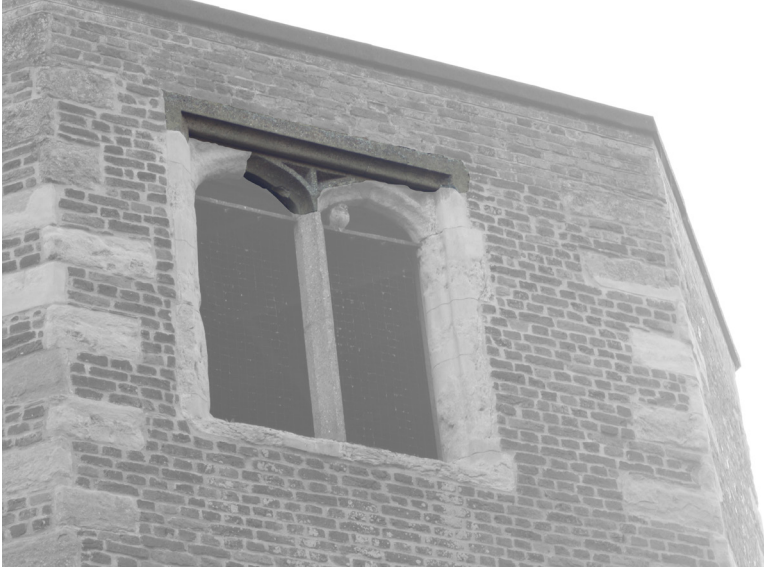
Figure 44: *Recent Stonework Surrounds* (2017)

Modern stonework repairs have restored this window casement. The new stone matches the expected original profile, though is more defined than the surrounding casement stones as has not been exposed to the elements for many years.

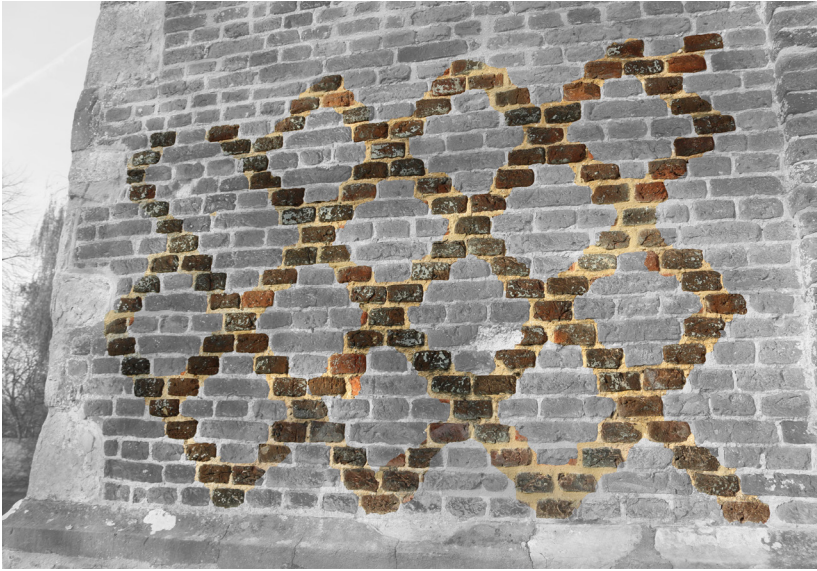
Figure 45: *Decorative Burnt Brickwork Pattern* (2017)

Decorative Brickwork

Burnt bricks were used for decorative purposes throughout Otford Palace. They make it extremely clear which elements of the surviving buildings were designed to be exposed to onlookers of The Palace, and which would have been hidden by previous structures or internal treatments.

In terms of significance, these decorative bricks have been exposed since 1515, when this burning of bricks was used as a decorative tool.

One of the most prominent architectural aspects identified were the decorative burnt brickwork patterns. The pattern identifies which parts of the scheme were designed to be left externally exposed, allowing a more sophisticated understanding on how The Palace was used.

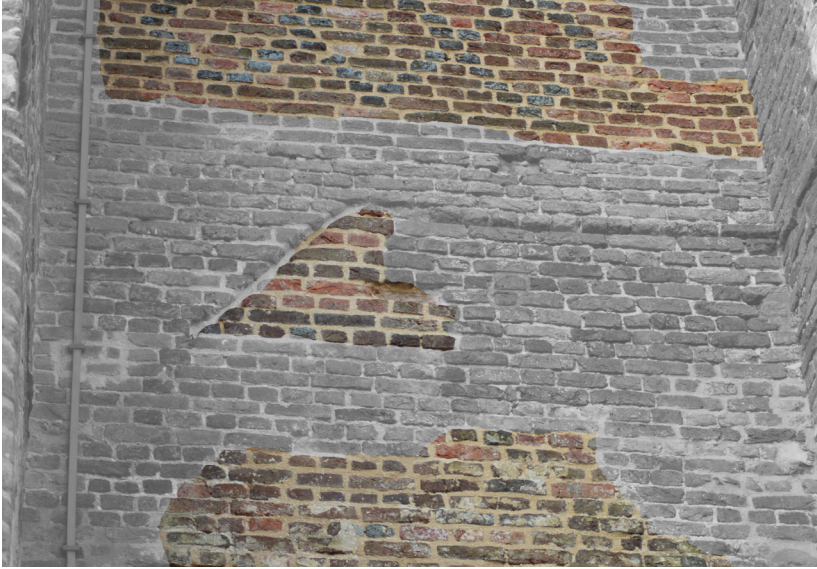
Figure 47: *Mortar Repairs To The Tower* (2017)

The mortar repairs to this existing brickwork were also likely to have been carried out during the recent works, due to their lack of discolouration. The colour and texture of the bricks match the rest of the wall, suggesting that they are original.

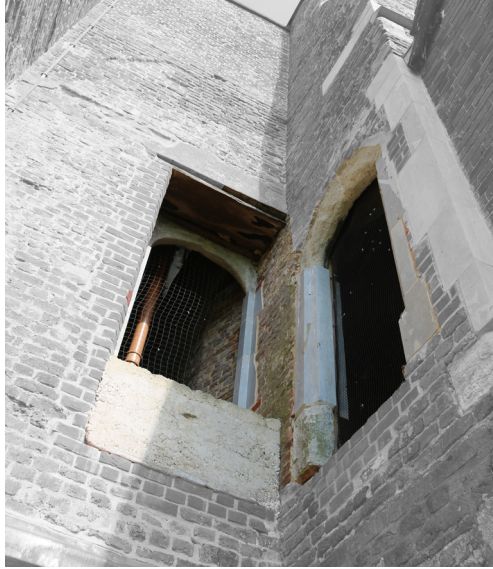
Figure 50: *Connection Between Circulation & Main Towers* (2017)

These exposed doorways to the first floor of The Tower show how the circulation Tower connected with the main octagon. The aligned brickwork either side of the openings make it clear that these were originally designed to be doorways, whilst the surrounding brickwork contains no decorative pattern, indicating that the long galley was two storeys high.

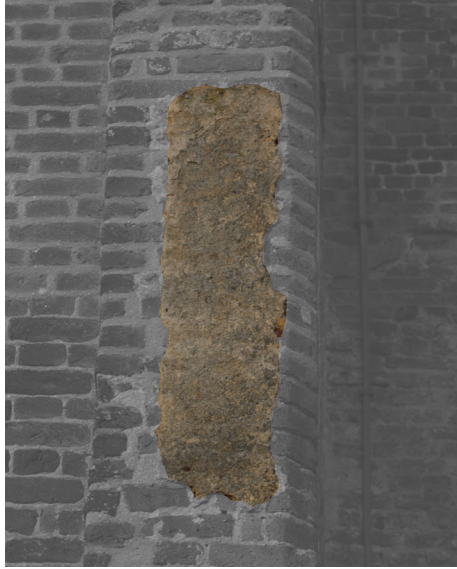
Figure 51: *Concrete Repair To Tower* (2017)

During the 20th century, a number of concrete mortar repairs were made to The Tower and Gatehouse. This image shows an area of brickwork that has been lost to concrete. This type of repair is both unsuitable and unsympathetic to historical buildings, as it does not allow the building fabric to breathe and detracts from The Palace's aesthetic significance.

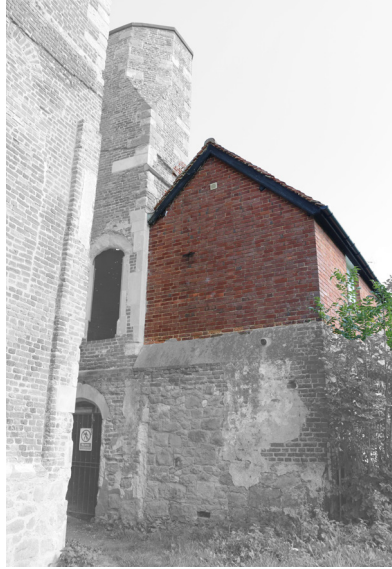
Figure 52: *Unsympathetic First Floor Addition* (2017)

20th Century Alterations

Judging by the location of the gable to the short gallery, it is likely that this stair Tower would have also provided access to the first floor of the long & short galleries, in addition to the corner Tower.

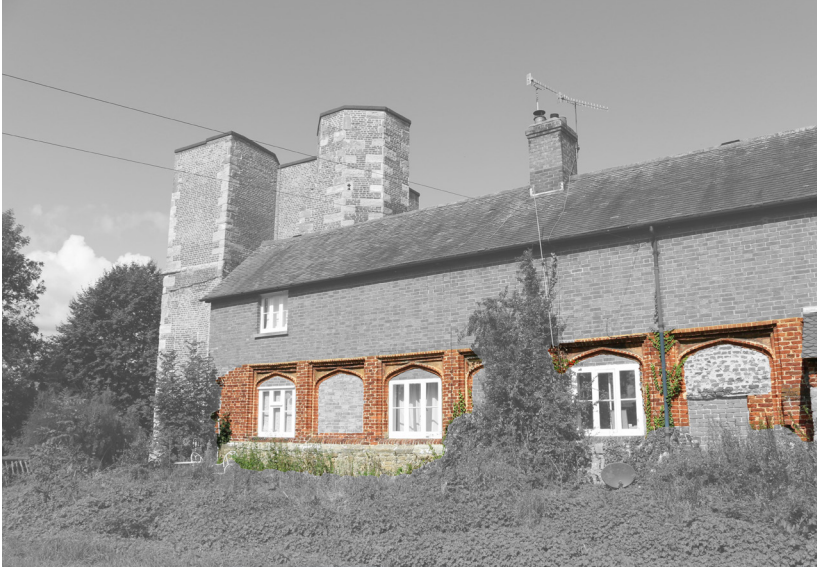
Figure 53: *Original Brickwork To Cottages* (2017)

The brick surrounds to the cloisters of the gallery, are still visible from the field to the south. The original brickwork highlighted above is substantially more textured, and lighter than the first floor above.
