# The Archbishop's Palace Conservation Trust

## Replacement lintels: Supporting the masonry for 500 years

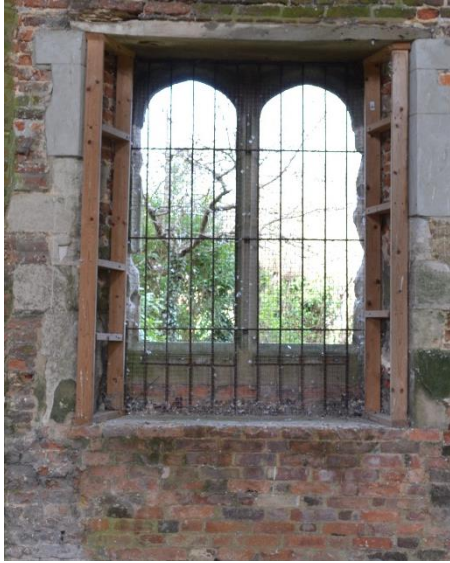
*Figure 3: Left: Window WG/02 on the ground floor. Two timber supports.*

The results of the test drilling were disappointing and confirmed that the lintels were about 80% rotten, and the engineer’s advice was that they should be replaced without delay.

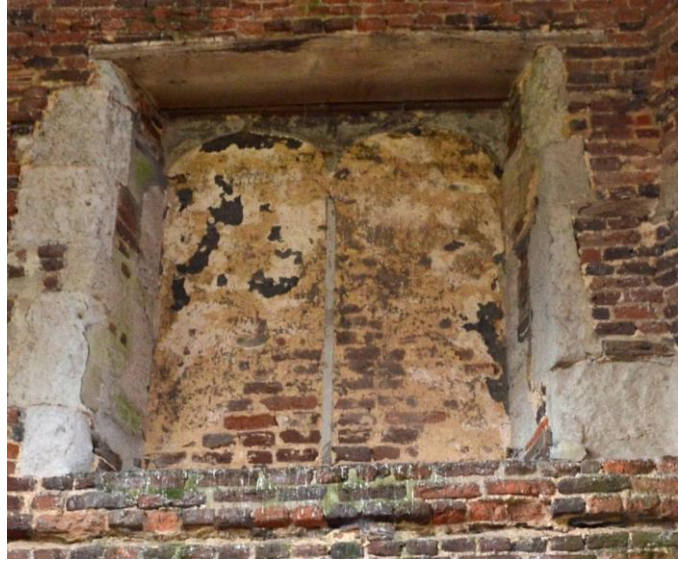
*Figure 4: WF/01 on the first floor with brick infill*

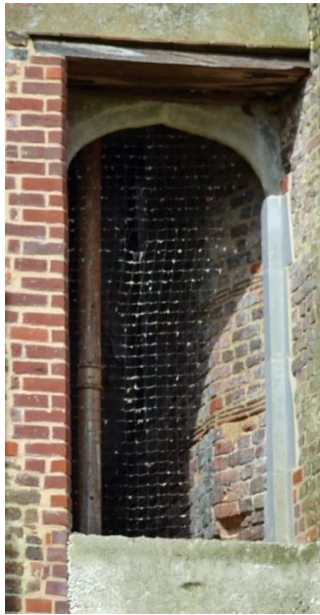
*Figure 5: Doorway DF/02*

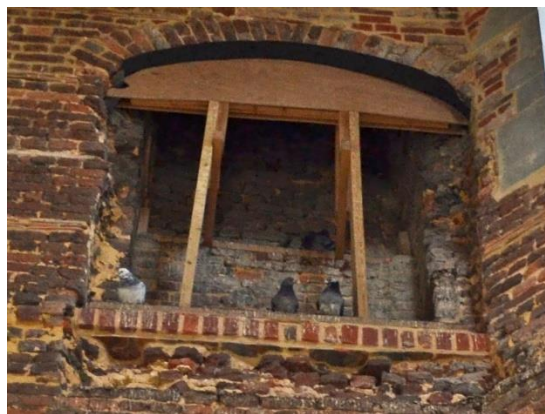
*Figure 6: Second floor fireplace*

The lintel above the fireplace on the second floor is well supported by a wooden framework installed in 2017 and although it will need to be replaced in the future, this work can wait until the main stage of the restoration works in 2025-6.

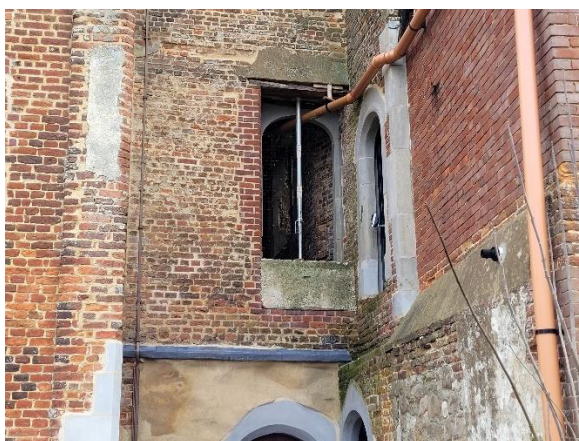
*Figure 7: A temporary Acrow prop to support the decayed lintel*

Acting on the advice of the structural engineer, we installed Acrow props as temporary supports for these three openings.

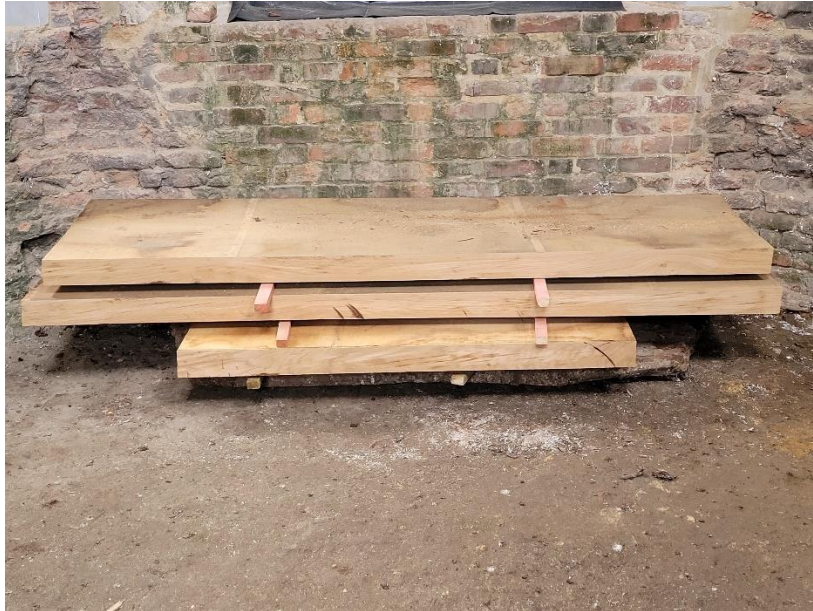
The lintels are large pieces of oak, over 2 metres long, 60cm wide and 85mm thick. Each piece weighs about 100Kg!

*Figure 8: The lintels are delivered*

The Archbishop's Palace Conservation Trust obtained competitive quotes from suppliers of oak in Kent and East Sussex. Round Wood of Mayfield were able to supply single pieces of air-dried timber. These were delivered to the Palace on 6<sup>th</sup> March.

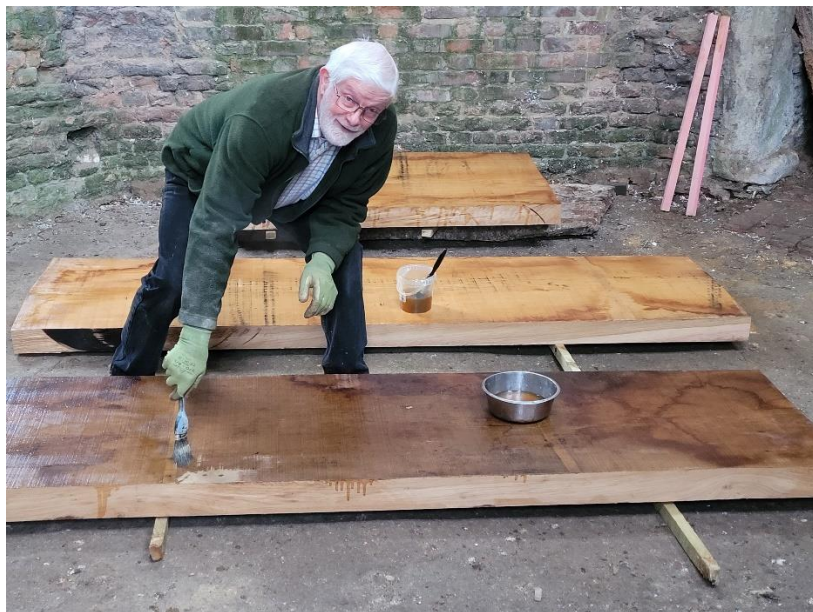
*Figure 9: Applying the preservative mixture*

Before the lintels could be installed, they needed to be treated with two coats of preservative. This is a mixture of beeswax, pure turpentine and boiled linseed oil.

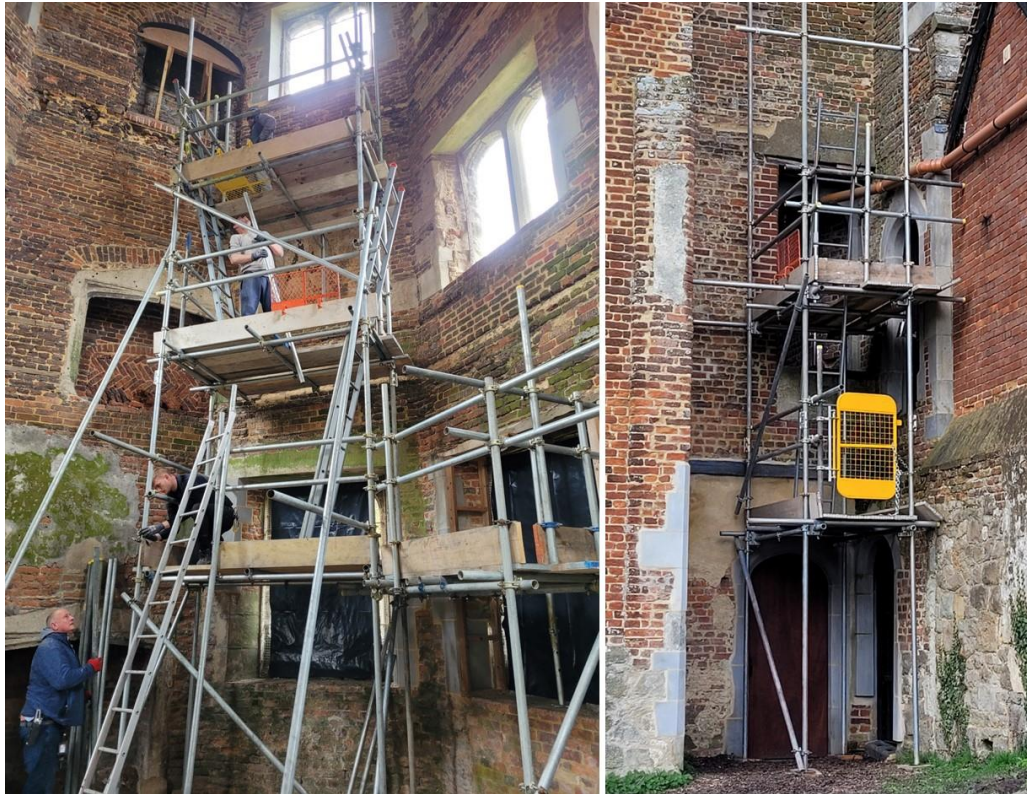
*Figure 10: Scaffolding for the lintel replacement - inside and outside*

JR Scaffolding erected the scaffolding on 23<sup>rd</sup> March in time for the work to start the following Monday.

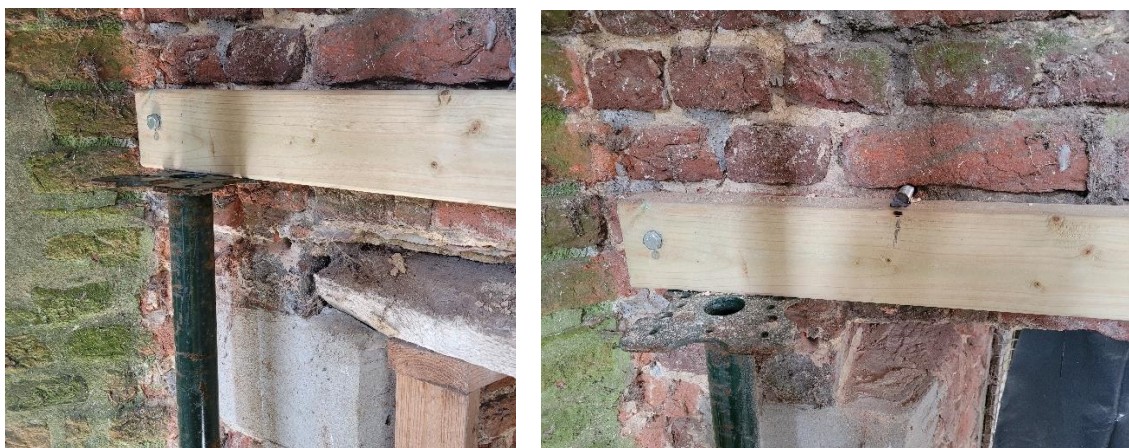
Figure 11 shows the how a substantial piece of timber was fixed above the window opening and then supported by an Acrow prop at each end, well clear of the ends of the old lintel.

*Figure 11: Support for the needles (visible in the right-hand image)*

On closer inspection, it became clear that the proposed approach of using strongboys would not work, because the supports would interfere with the extraction and insertion of the timber. Plan B was therefore to use 'needles' – rods that go through the masonry above the lintel and support it while the lintels are removed. This support is crucial: without the lintel in place, the bricks above the window could be dislodged and, in the worst case, the whole of the wall could collapse!

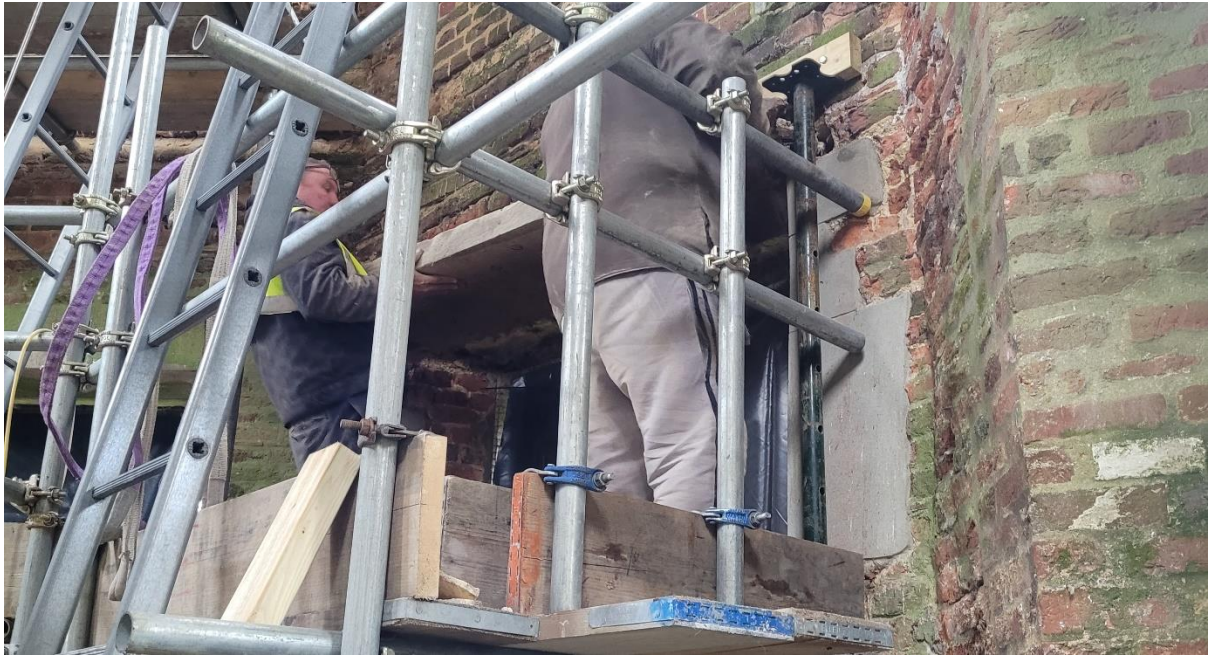
With the bricks above the lintel being supported, it was then possible to remove the old timbers. That revealed the extent of the decay which had not been visible earlier.

*Figure 12: Removing lintel WF/01*

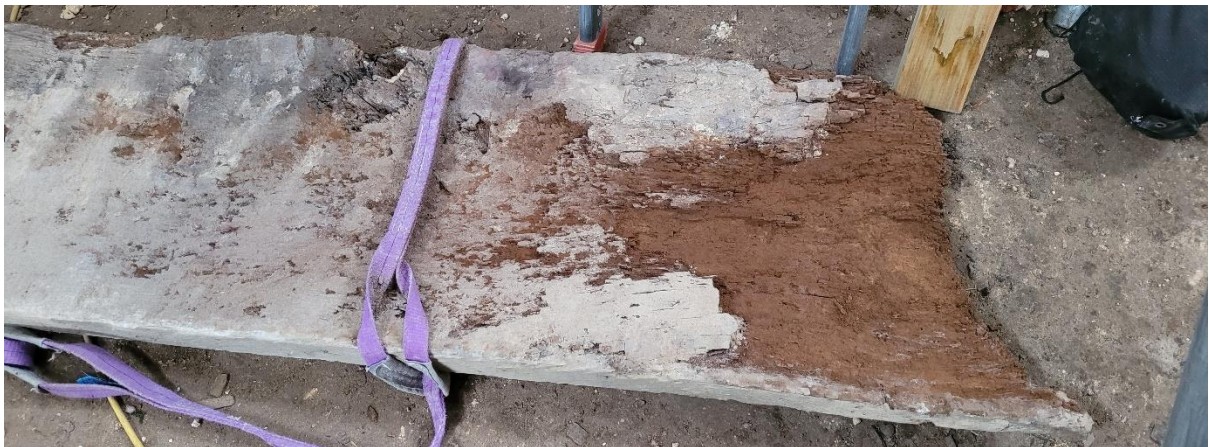
*Figure 13: Decay on lintel WG/02*

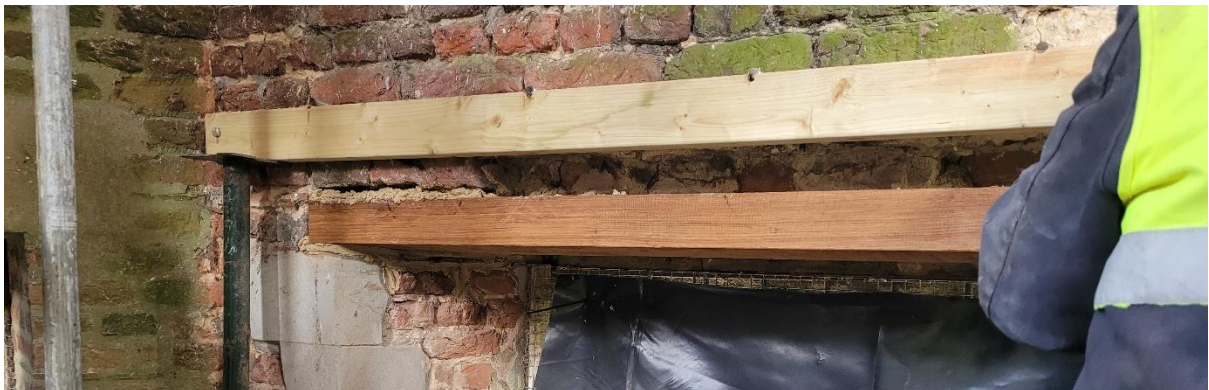
*Figure 14: Sliding the new lintel for WG/02 into position*

Using the old lintels as templates, the new oak was cut to size and then lifted into position. Given the right saw, oak cuts surprisingly easily!

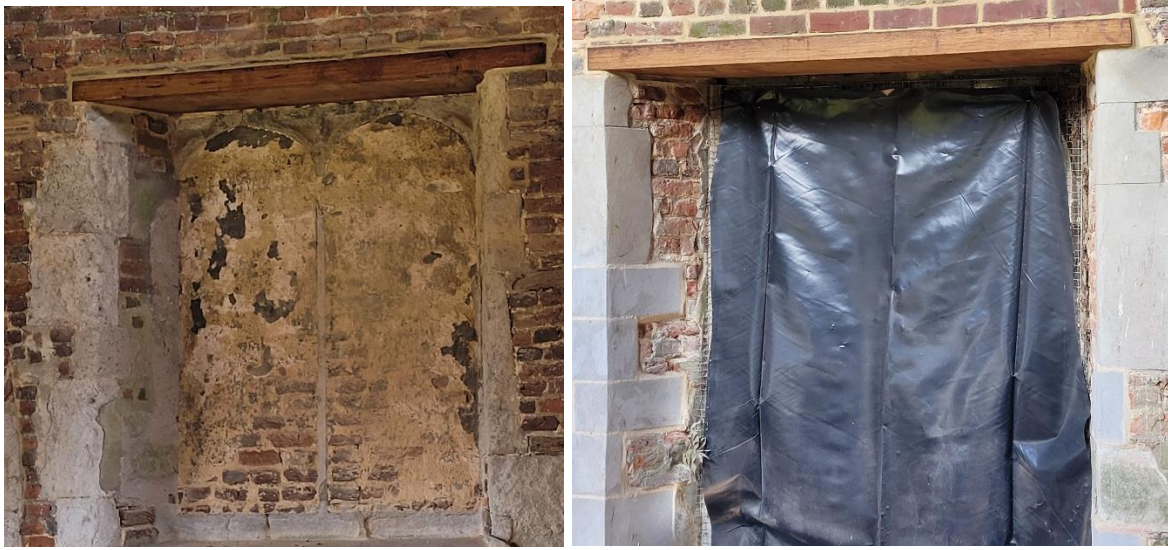
*Figure 15: The new lintels WF/01 and WG/02*

Once the mortar had hardened the support and the needles were removed and lime mortar

was injected into the holes left by the needles. The new lintels should be good for another 500 years!
