Otford Palace

The Archbishops Palace Conservation Trust

Otford Palace Orchard watching brief (OPO24)

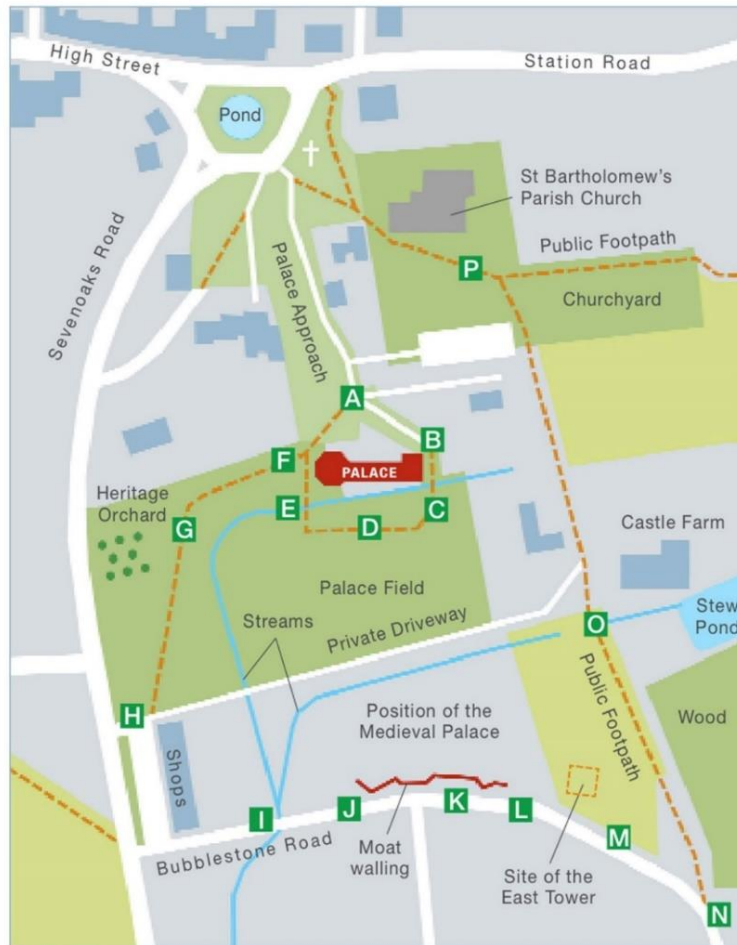
Figure 1 A schematic map of the palace site remains. The earlier Heritage Orchard is shown. The path G-H crosses the field to the west of the palace, and the new orchard was planted to the left (west) of this path. (Map by Cliff Ward).

The Archbishops of Canterbury had a medieval moated manor to the north of what is now Bubblestone road. In the early 16C archbishop Wareham built a large Tudor courtyard adjoining and to the north of the old palace. After centuries of decay the main visible areas now are the Tudor NW tower and a gallery running east to join the truncated remains of the western half of the gatehouse. There are no standing remains of the western or eastern ranges. A stream runs just to the south of the northern range in a westerly direction before turning at right angles to run south, forming the eastern edge of the present orchard area (Fig 1).

It is not known whether the Tudor formal garden was limited to the area between the western range and the small stream running north to south, or whether the garden also included some of the area to the west of the stream (the existing orchard field) (Fig 1).

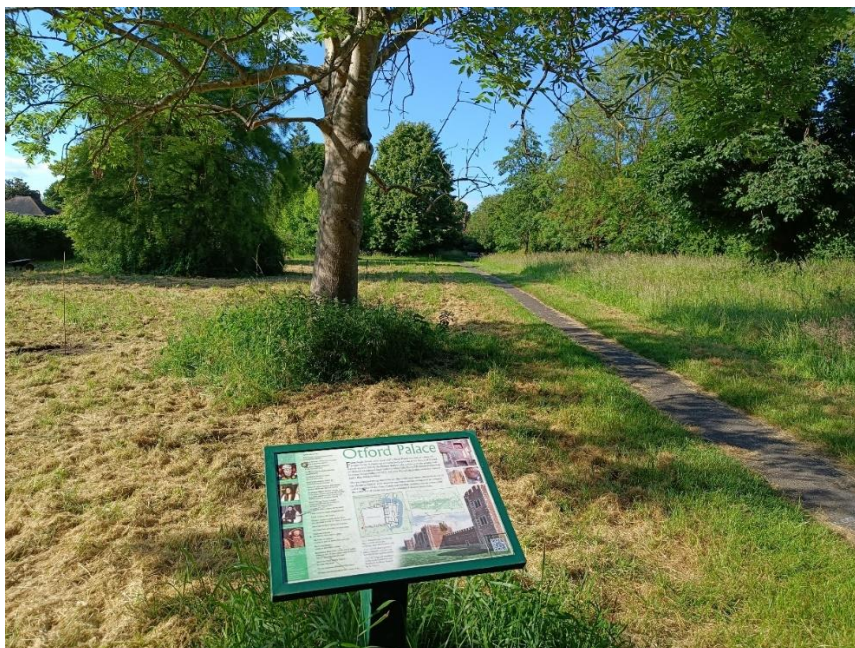
Figure 2 Palace Orchard seen from the south, before the new orchard was planted. The Otford-Sevenoaks Rd runs behind the hedge on the left (west). The path on the right (east) is that shown in Fig 1 as G-H.

The tithe map of 1844 shows that the present orchard site was a field at that date and was described as “meadow”. The tithe map and subsequent OS maps and aerial photographs show no buildings on this site. Fig 2 shows the present field shortly before the new orchard was planted.

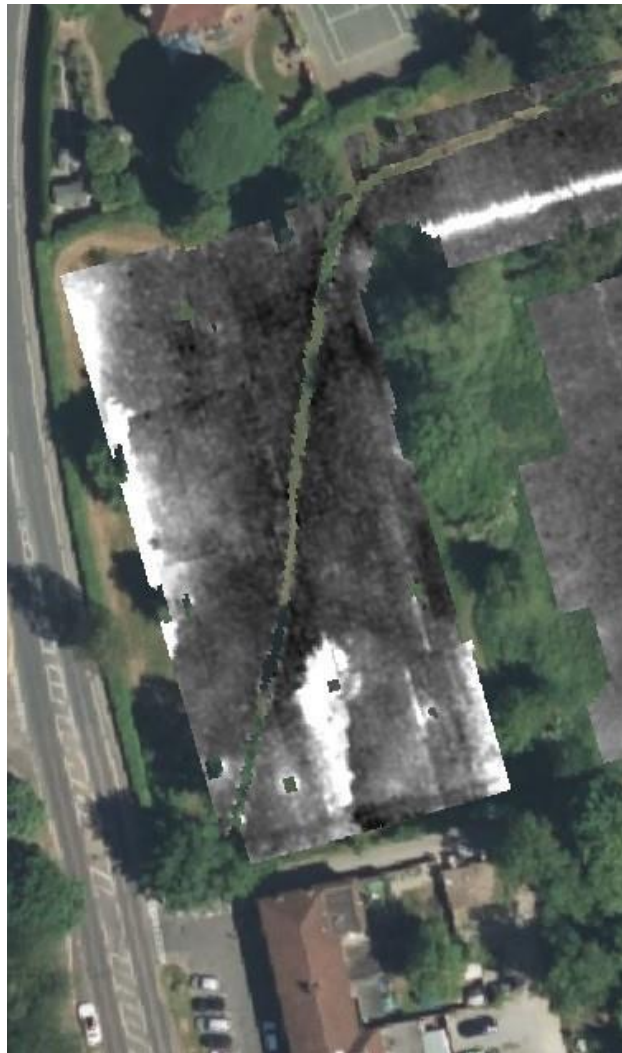
Figure 3 Detail from 2023 resistivity survey showing the orchard site. The Otford-Sevenoaks Road is on the left (west) and the stream runs N-S through the green area on the right (east). There are no obvious linear archaeological features in the orchard. There are non-specific high resistance areas adjacent to the road and in the south. The linear high resistance line in the NE shows the presence of a known underground water conduit. (Image Copyright, courtesy of Anne Sassin and DVLP, and not to be reproduced without permission.)

In Summer 2023 a high resolution 0.5x 0.5m resistivity survey of the palace site was conducted by Anne Sassin and volunteers from the Darent Valley Landscape Partnership (DVLP). This did not show any suggestion of archaeological remains in the palace orchard area (fig 3). However, had there been flower beds in that area these would not necessarily now be visible on the geophysics survey.

Resistivity survey does not indicate possible structures in the orchard field to the west of the stream. The 16 pits scattered over this field did not uncover archaeological features and there was a paucity of finds when compared to those uncovered by recent watching briefs on holes dug nearer the palace itself.

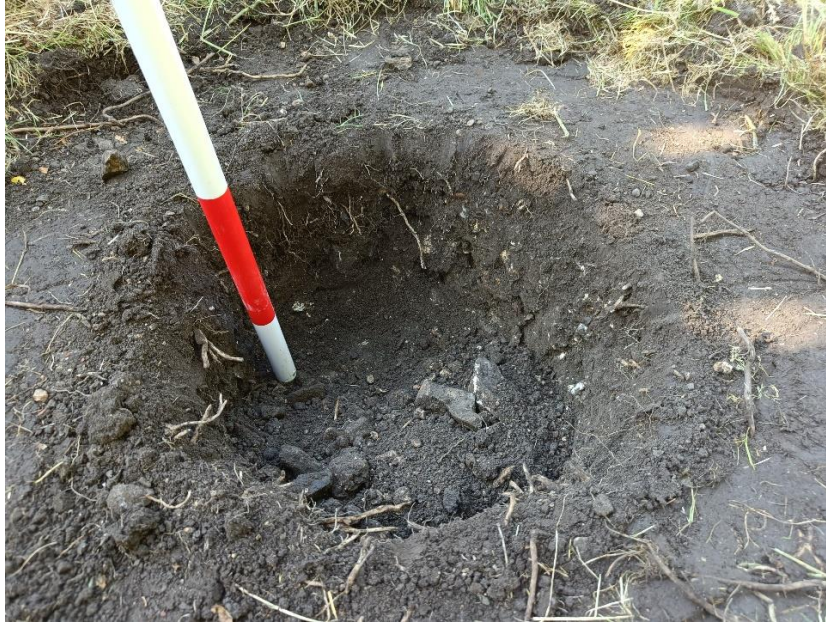
Figure 5 Unlike the pits on the eastern side of the orchard, Pit 5 on the western side, near the hedge, contained some rubble in its base.

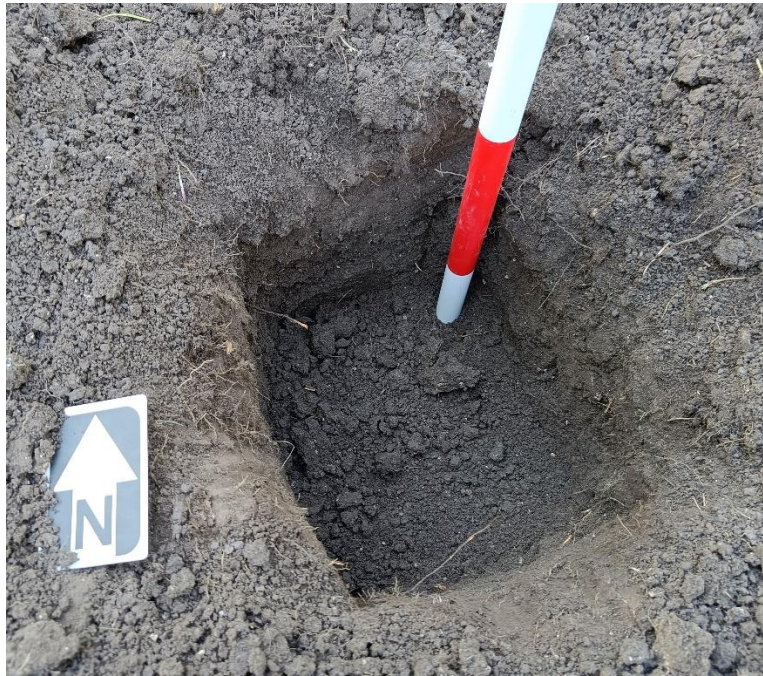
Figure 6 Pit 9 contained rich soil and was devoid of finds

Pits 9 and 16 were 0.3m deep, but square in shape, 0.4 x 0.4m. They contained rich soil throughout and were notable for the lack of finds and the lack of clear stratigraphy (Fig 6).

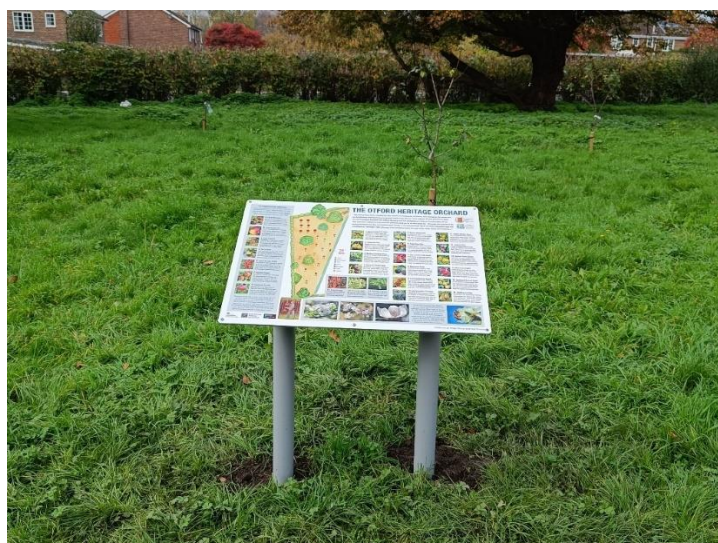
Figure 7 Information plaque showing the varieties of the various trees.

Later in the year on the eastern edge of the Orchard an illustrated information plaque was installed, supported on 2 metal poles (Fig 7). I inspected all the soil from these 2 small augers. There was no metallated surface below the grass and the soil was dark with slight clay. No artefacts were found. There were a few small and medium sized unworked flints.
