# The Archbishop's Palace Conservation Trust

## Statement of archaeological significance

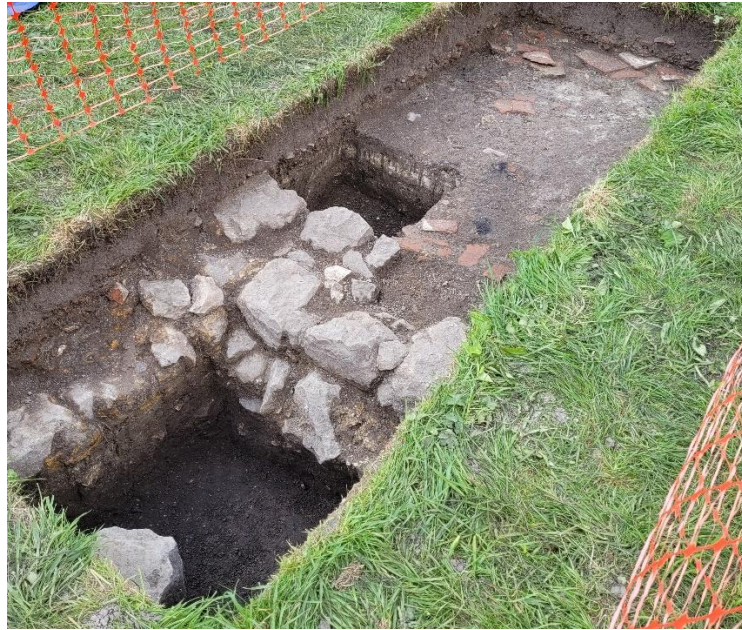
*Figure 8: The exploratory trench on the site of the medieval building in the Great Inner Court*

The site of this medieval building was investigated in April 2025. The two exploratory trenches revealed the foundations and a section of tiled floor outside the south-wester entrance. The date of the building is between 1250 and 1350: a more accurate carbon date is awaited.
