# Otford Palace

The Archbishops Palace Conservation Trust

## The North-West Tower

Nick Rushby, Archbishop's Palace Conservation Trust  
Orcid: <https://orcid.org/0000-0002-2379-1402>

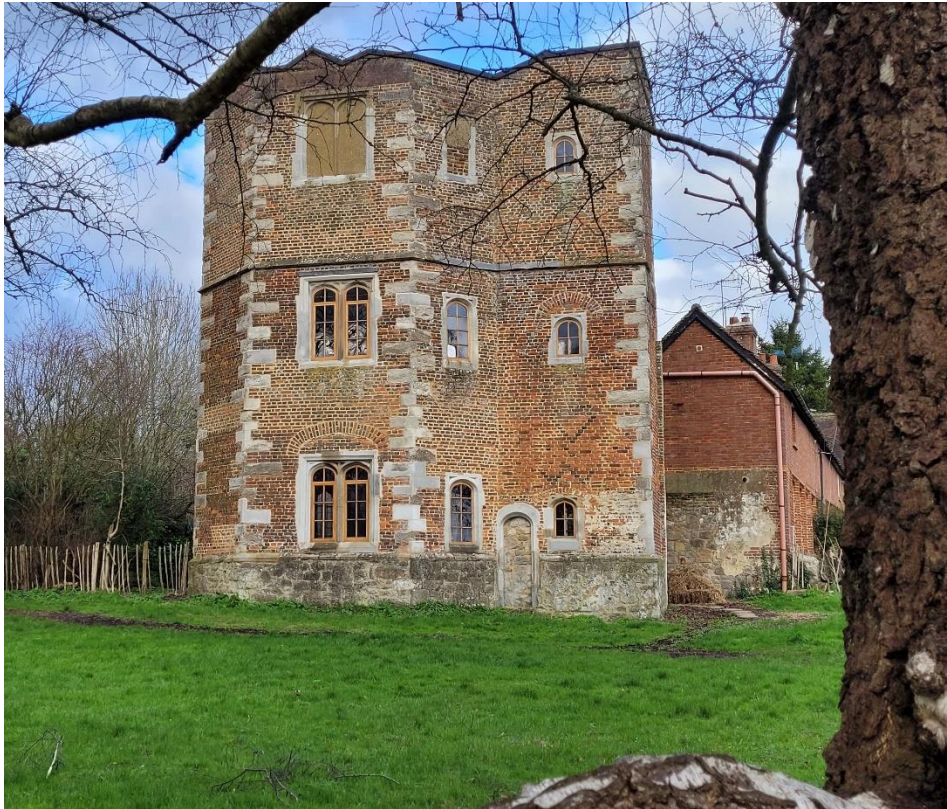
Figure 1: The Tower from the south west

Historic England. Then in 2022-23 the Archbishop's Palace Conservation Trust raised nearly £250,000 for more stabilisation work to the brickwork and masonry. The Tower was glazed for the first time in over 300 years (figure 1).

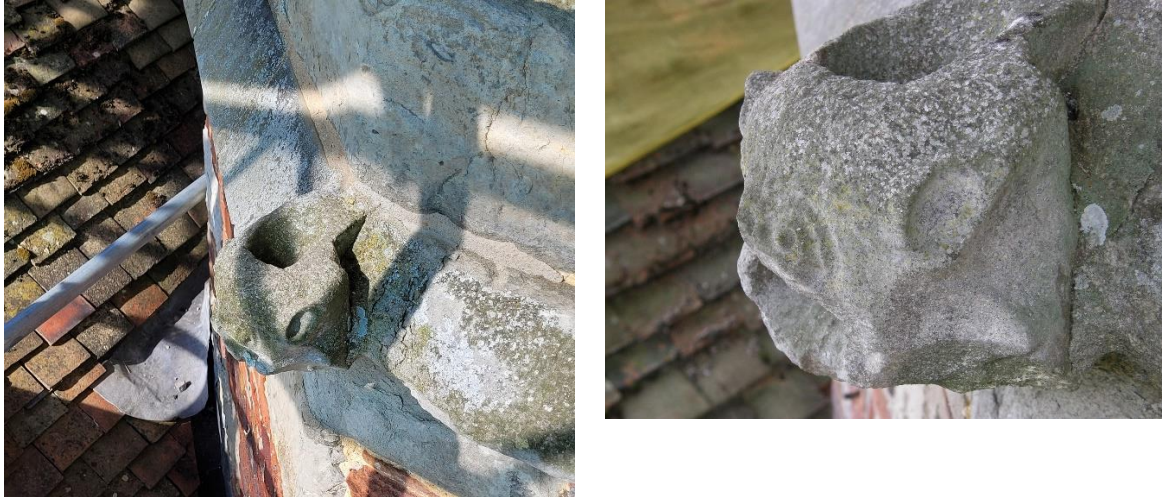
Immediately above the first-floor windows there is a string course of Kentish ragstone and set into that stone are a number of water chutes to direct rain water clear of the walls. Two of these chutes take the form of gargoyles (figure 4).

*Figure 4: Gargoyles in the first-floor string course*

This poses the question of why there should be water chutes half way up the building? The current hypothesis is that the Tower was originally built with only two storeys. However, when Warham learned that his rival Cardinal Wolsey had built three storey towers, he ordered his architect to add a further storey giving us the tower we know today. The Trust intends to commission two new gargoyles to replace the originals which have now weathered beyond restoration.

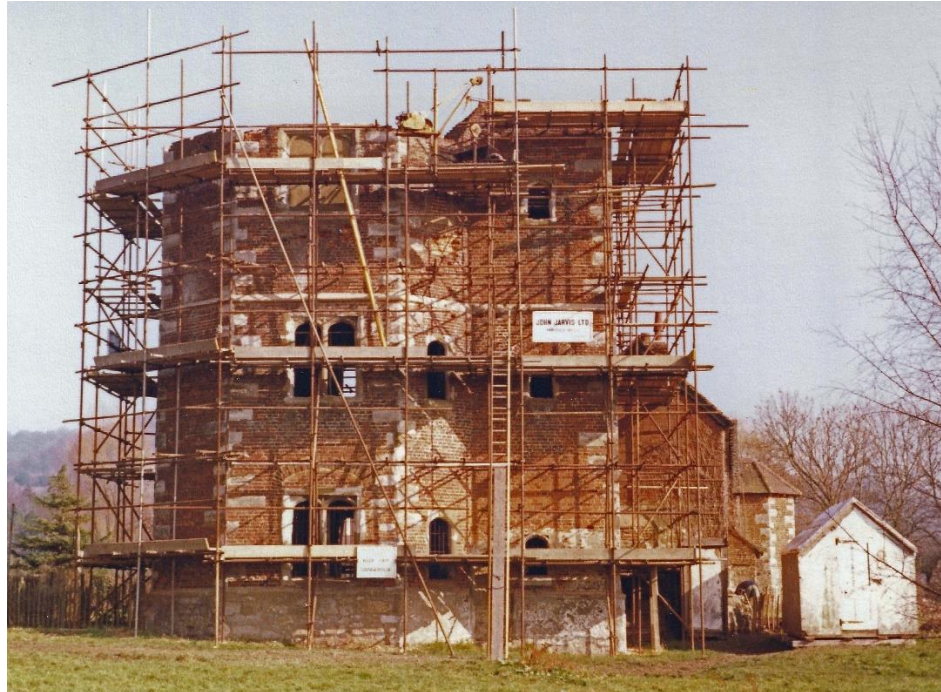
*Figure 6: Repair works in 1982*

In early 1981 a vituperative debate raged between a group of Otford residents, led by Anthony Stoyel and Sevenoaks District Council over the state of the Tower and the Council's responsibility to repair it. This drew in contributions from the Department of the Environment, Sevenoaks District Architectural History, The Kent Building Preservation Trust, the Ancient Monuments Society, Otford Parish Council, and the Otford Society (see: <https://otfordpalace.org/wp-content/uploads/2024/01/A-new-roof-for-Otford-Palace-Tower-1982-v2-compressed.pdf>). The Council fought a rearguard action but was eventually overwhelmed by public opinion and commissioned repairs to make the building safe.

The Trust is embarking on an ambitious restoration programme that will see the Tower become an interpretation centre for the Darent Valley. This will involve reinstating the ground, first and second floors, reinstating the spiral stairs and building a temporary vestibule on front of the entrance door to shield visitors from the weather and enable access from the stairs to the first floor. A new roof will replace the temporary structure of 1982.
