**Archaeological Evaluation Report
North-West Tower
Otford Palace, Otford
Kent**

**Scheduled Monument No: SM KE 9, HA 1005197
SMC Ref: S00247831**

**ASE Project No: 240016
Site Code: ABP25
ASE Report No: 2025241
OASIS id: archaeol6-537939**

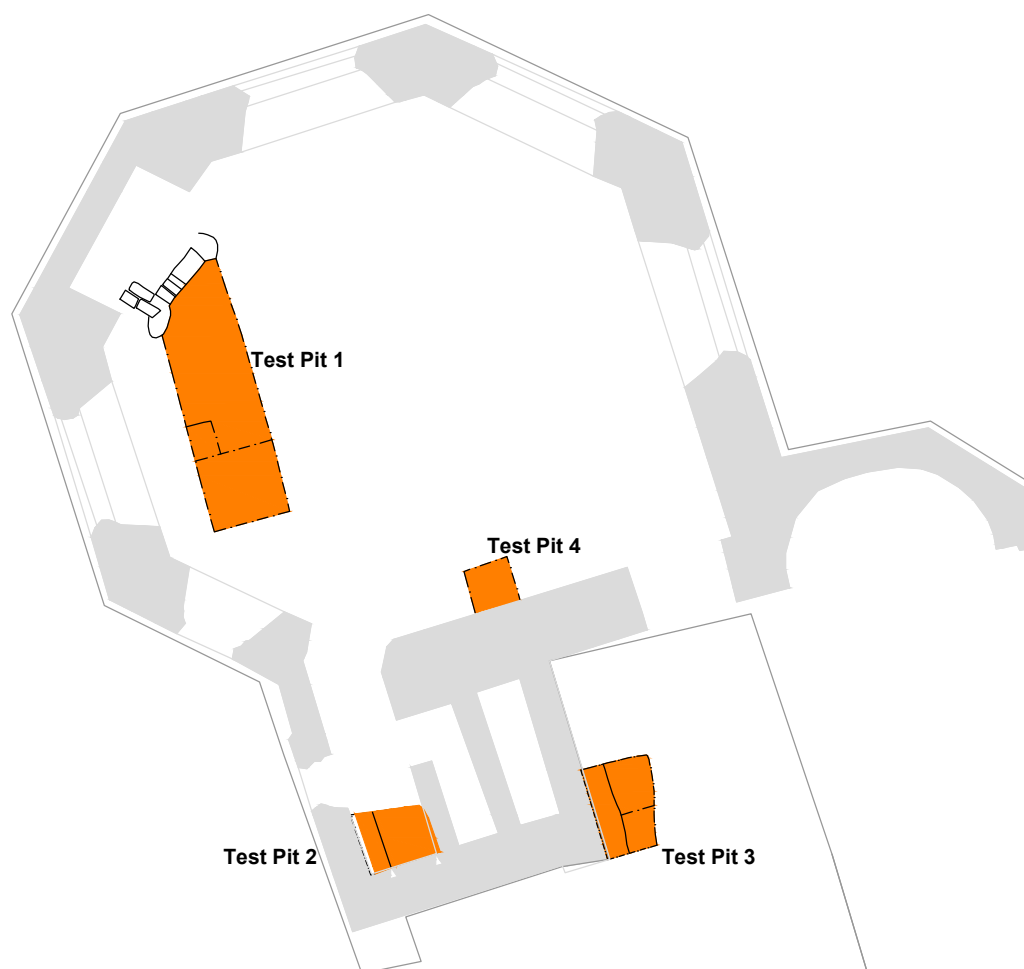
© Archaeology South-East		Otford: Archbishops Palace	Fig.3
Project Ref: 240016	October 2025		
Report Ref: 2025241	Drawn by: AC	Trench locations

- 3.1.2 All test pits were placed where accessible and where it would not interfere with access and egress within the tower. Test pit 1 was located inside the main tower and measured 2.5m by 0.80 wide. A deeper sondage was excavated towards the southern end of the test pit. Test pit 2 was located within the garderobe off to the side of the tower, this measured 0.76m by 0.53. Test pit 3 was located outside the entrance to the tower and measured 1.77m by 1.1m. A deeper sondage was excavated towards the southern end of the test pit.

- 3.1.3 Test pit 4 was located just inside the doorway, to check that the results of Test pit 1 continued further into the room. This measured 0.50m by 0.50m.

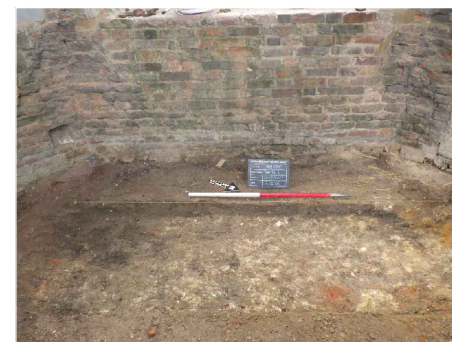
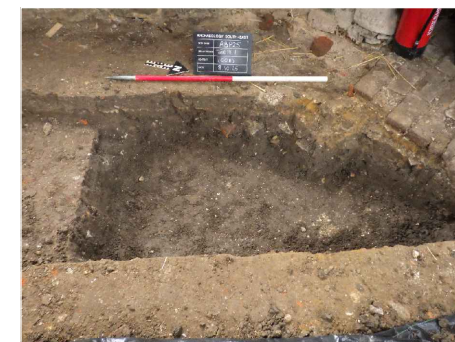
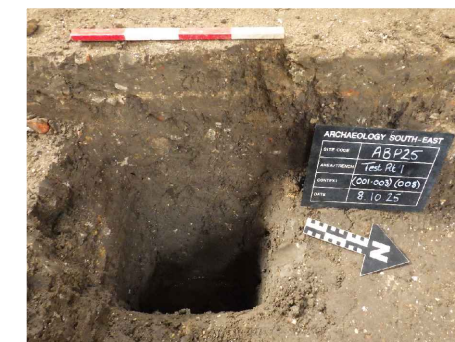
TP1 looking south-west

- 4.1.1 Test pit 1 was the largest of the test pits and was located near to the fireplace in the north-west corner of the ground floor of the tower.
- 4.1.2 The stratigraphy for this test pit consisted of a dark brown grey, clay silt layer, [008], which produced occasional snail shells. Water ingress caused the excavation to cease at 0.77m depth below ground level.

- 4.1.3 Layer [008] was overlain with by a similar dark, brown, grey, silt clay layer, [003], which produced Ceramic Building Material (CBM) comprised of roof tile dated to the medieval - post-medieval period. Two fragments of Roman to the post-medieval period iron nails were also collected along with animal bones comprised of cattle, dog and birds which are likely indicative of the disuse of the tower over time.

- 4.1.4 Overlying [003] was a thin, patchy layer of mixed mortar and dark grey, silt clay, [002], which may be the remains of a partly robbed-out and trampled floor surface.

- 4.1.5 Above this, located close to the fireplace, was a thin layer of orange sand, [019] which was likely bedding for the floor.
- 4.1.6 This was overlain by a thin layer of mortar [018].

- 4.1.7 This was overlain in places by several bricks and stones, [017] forming the fireplace floor.
- 4.1.8 Across most of the test pit a layer of trample [001] was recorded at the top of the sequence. This comprised a mid-grey brown, silt clay and produced a small assemblage of medieval CBM. A small quantity of roof tile with glaze splashes present indicates the medieval date alongside a single fragment of green glazed floor tile. However, the remaining CBM from the layer comprised of post-medieval material.

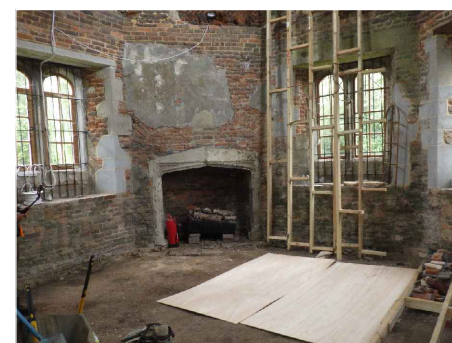
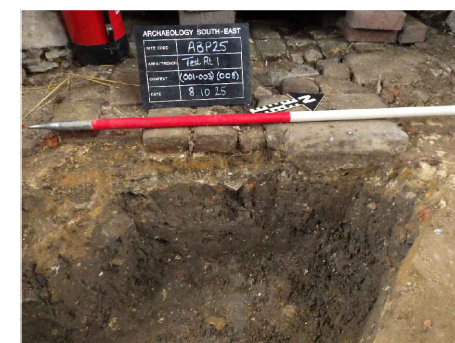
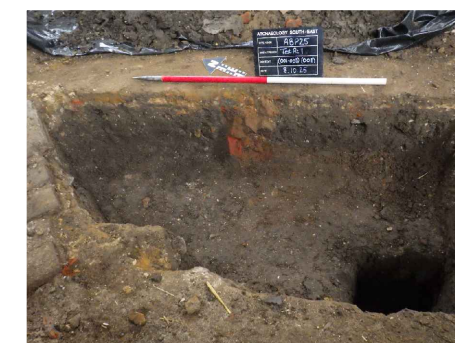
Test pit area looking north-west

TP1 looking north-west

TP1 looking north-east

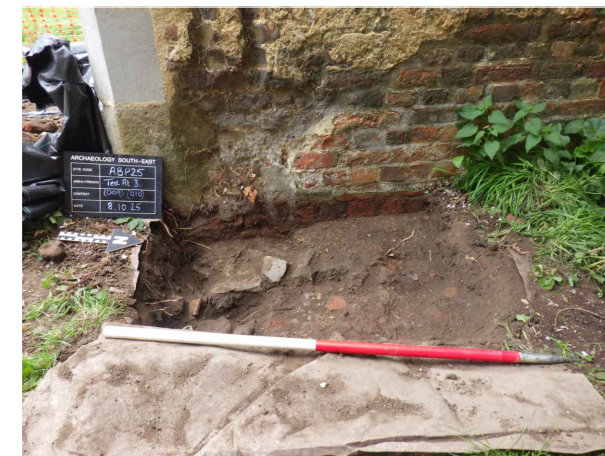
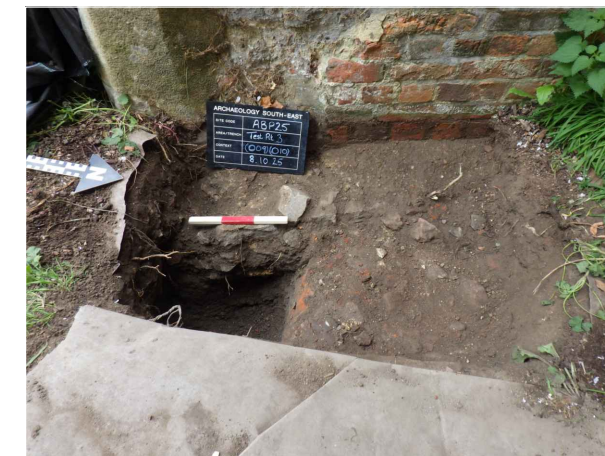
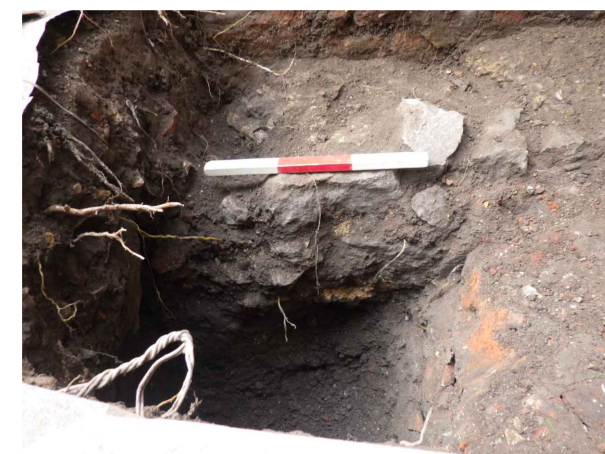
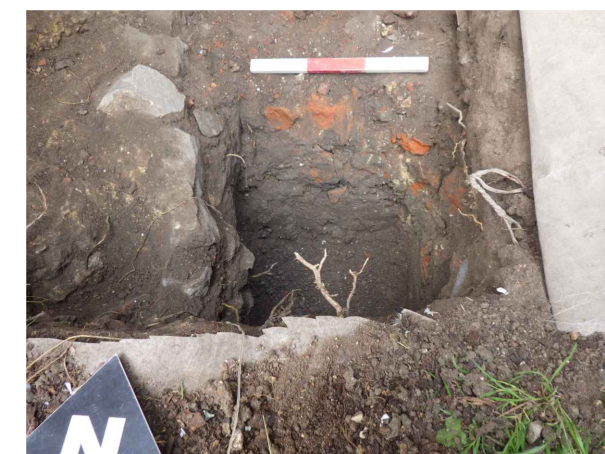
4.3.1 Test pit 3 was located outside the door to the tower, at the south-east of the corner of the garderobe. Due to the access in and the area being tight, the test pit measured 1.77m by 1.10m. Water ingress caused the excavation to cease at 0.63m depth below ground level.

4.3.2 The lowest deposit encountered was a layer of soft, light, brown, grey, silt clay [011], which produced moderate fragments of CBM which included roof tile dated medieval to post-medieval as well as fragments of brick and mortar dated from the 19th century. A fragment of salt-glazed stoneware pipe of 19th-20th century date was also recovered from this deposit.

4.3.3 Along the western side of the test pit, the footing for the existing tower wall, comprised of stone and mortar [016], which was found 0.18m below ground level.

4.3.4 This was overlain by a dark brown grey, silt clay [010] with frequent roots which produced a small group of roof tile, floor tile and brick dated between the medieval and post-medieval period alongside fragments of Welsh roofing slates. A small assemblage of pottery, all dated to the late post-medieval period, as well as fragments of glass dated to the 19th-20th century. Fragments of animal bones from a sheep or goat were recovered alongside a number of fragments of metalwork which includes two registered finds, <1>, an iron horseshoe and <2> an iron staple, both of which are likely post-medieval base on the surrounding material.

4.3.5 This deposit was then overlain by a layer of Terram sealed with a layer of topsoil, [009], a loose, mid-brown grey, silt clay.

TP 3 looking west

TP 3 looking south-west

TP 3 looking north
